- A. New Ride-Guide Steering Cable Recommendations
- B. Merc 1500 Mid-Range Lean-Out
- C. Engine Harness Rerouting to Prevent Chaffing

C. ENGINE HARNESS REROUTING to PREVENT CHAFFING - 1975 and 1976 MERC 1150 and 1500 MODELS below SERIAL NO. 4122702

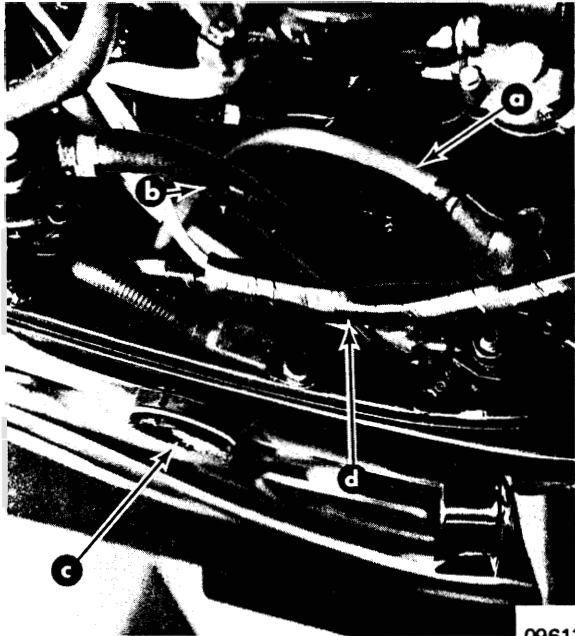
Figure 1. Incorrect Engine Harness Routing

The above models may have the large, red internal engine harness wire routed between the fuel line and the cylinder block, as shown in Figure 1, which could allow the wire to chafe. To prevent this, check all units that you service and reroute the red wire as shown in Figure 2. Seal the solenoid connection with Liquid Neoprene (C-92-25111).
