- A. New Propellers for Merc 402-500-650-700
- B. Model 1976 Merc 850 Water Inlet Tube
- C. Service Aids Updated

A. NEW PROPELLERS for MERC 402-500-650-700

B. MODEL 1976 MERC 850 WATER INLET TUBE

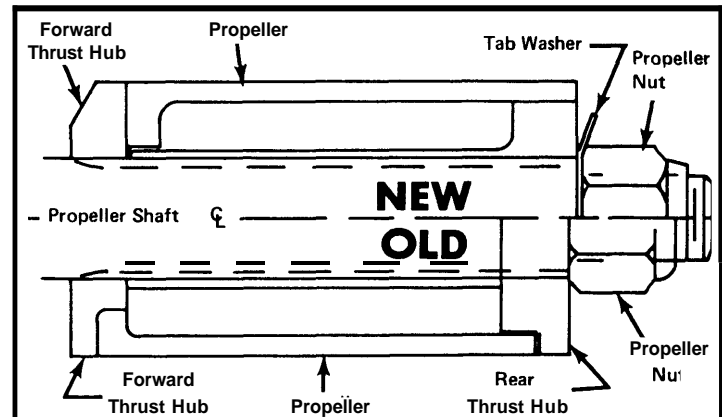
Figure 1. Propeller Installation

The new line will adapt to any 1970 and newer Merc 402-500-650 (3-Cyl.) model by simply replacing the forward and rear thrust hubs with a new forward thrust hub and tab washer (listed below). (Figure 1)

All 1977 Merc 402-500-700 models (above Serial No. 4564001) will be shipped with the new thrust hub and tab washer that are designed for use with the new propellers. We recommend using the new propellers with these 1977 models; however, the current (1976) propeller line can be utilized if the new forward thrust hub (A-73345) is replaced by the old style forward thrust hub (A-65758), then adding the old rear thrust hub (A-62124A1). (Figure 1)

A-73345 Forward Thrust Hub

A-14-76281 Tab Washer

A-65758 Forward Thrust Hub

A-62124A1 Rear Thrust Hub
