- A. Starter Solenoid to Starter Motor Cable Chaffing - 1974 Merc 650
- B. Exhaust Cover Screw Torque - 1973-74 Merc 650
- C. Relief Valve Diaphragm Bleed Hole Leakage - 1974 Merc 650

## A. STARTER SOLENOID to STARTER MOTOR CABLE CHAFFING - 1974 Merc 650

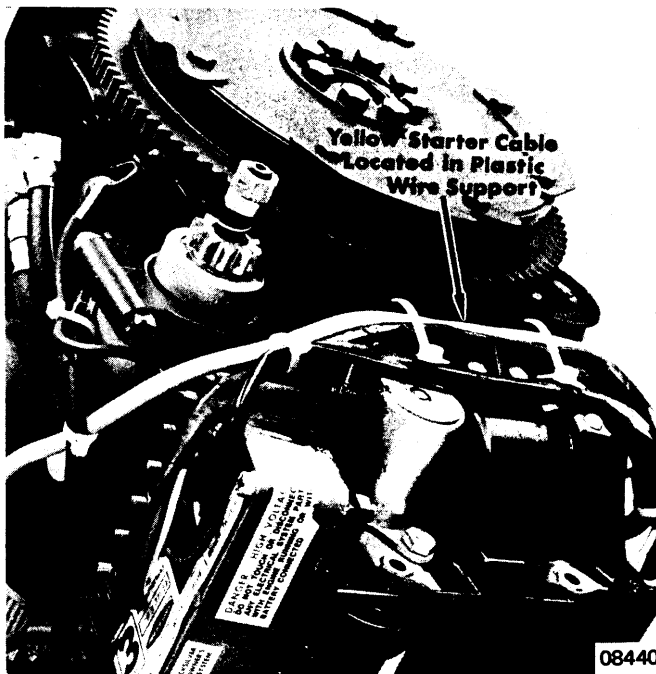
Figure 1. BEFORE Relocating Cable

A starter motor change on 1974 Merc 650 Outboards (below Serial No. 3813358) could cause the yellow starter cable to chafe on the switch box. (Figure 1) To remedy, relocate the yellow cable and sta-straps (C-61990) as shown in Figure 2. Complete this relocation on all 1974 Merc 650's below Serial No. 3813358 at a labor allowance of 0.3 hr.
