NUMBER: 79-3

DATE: 1/15/79

- A. Maximum Advance Timing Procedure and Throttle Cable Adjustment - 1979 Merc 7.5 and 9.8
- B. Stiff Throttle Operation - 1979 Merc 7.5 and 9.8
- C. Throttle Cable Chafing - 1979 Merc 7.5 and 9.8

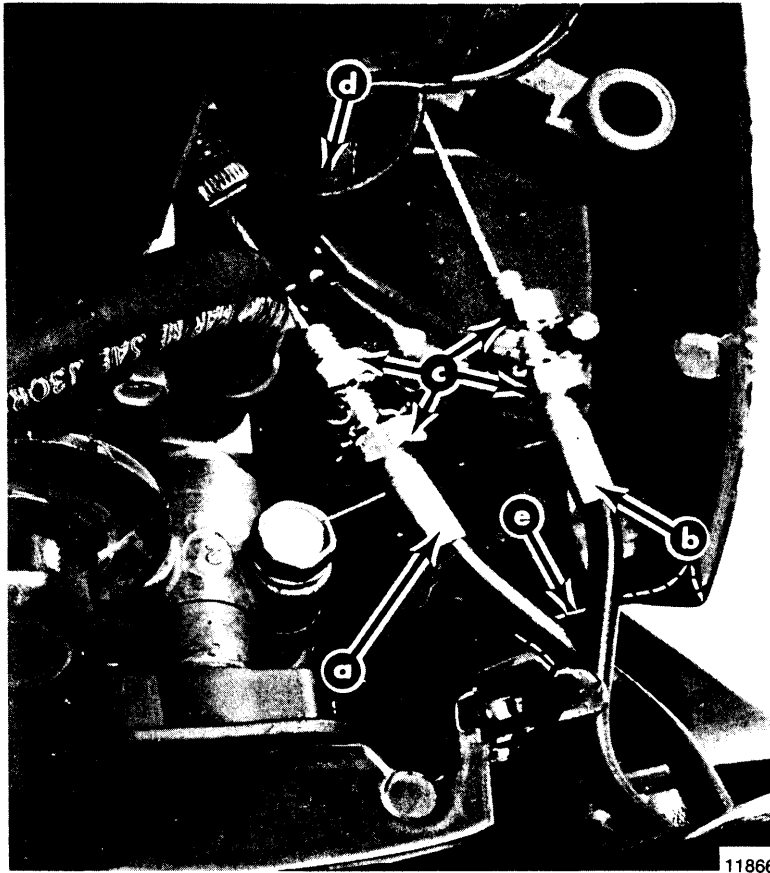
**Figure 1. Throttle Cables**

We have received a few reports of the throttle cables chafing against the bottom cowl on some 1979 Merc 7.5 and 9.8 Outboards, with the "Pull/Pull" (dual) throttle cable system.

1. Make certain that the throttle cables are properly adjusted (refer to Part "A" of this Service Bulletin).
2. Position the cables (conduits) between the handle and the bottom cowl to gain access to the cable opening in the cowl. (DO NOT BEND or KINK the cables.) Then, using a small, round file, smooth-off any sharp edges (both sides and bottom) in the cable opening thru the cowl. (Figure 1)
3. After smoothing-off any sharp edges in the cable opening, reposition the cable conduits (between the handle and bottom cowl) to provide the best possible cable clearance thru the opening in the cowl.
