NUMBER: 80-15

DATE: 10/13/80

- A. Thermostat Deletion - Merc 7.5 and 9.8
- B. Metric Tool Requirements - Merc 18 and 25
- C. Premature Drive Shaft Spline Wear - 1979 Merc 20 (Short Shaft)

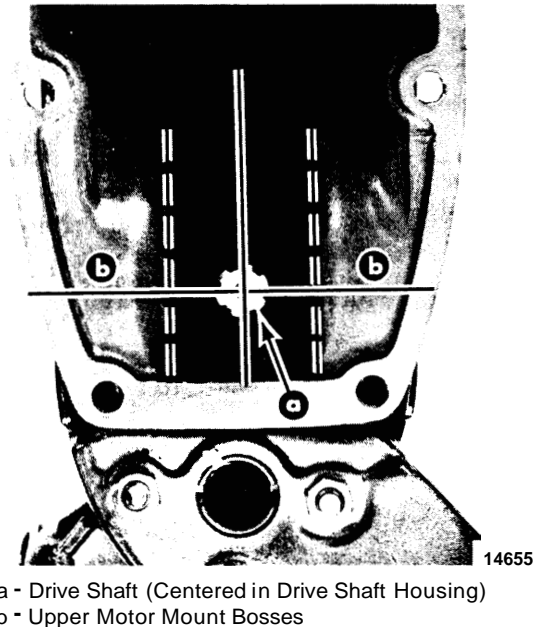
Figure 1. Top View of Drive Shaft Housing

Inspection of these types of failures has revealed that the premature wear results from misalignment between the drive shaft and crankshaft, caused by improper machining on the bottom end of the drive shaft housing (A-1561-6007A2).

1. Remove powerhead assembly complete, bottom cowl and mounting plate assembly from lower unit.
2. Install gear housing assembly complete on drive shaft housing.
3. Viewing the drive shaft housing from **top** end, check the position of the top end of the drive shaft in relation to the drive shaft housing. (Figure 1)
4. The drive shaft **MUST BE CENTERED** laterally (port to starboard) between the drive shaft housing upper motor mount bosses, **WITHIN 1/8"** (3mm).

1. Drive shaft housing must be replaced if alignment does not check to specification (refer to "Drive Shaft Housing - Alignment Check", preceding).
2. Whenever spline wear is evident on the upper end of the drive shaft, the spline in the lower end of the crankshaft **MUST ALSO BE INSPECTED** for probable damage.
3. If both the drive shaft and crankshaft must be replaced, we recommend installation of 1980 components. The 1980 drive shaft [A-45-88094A] (short shaft) and crankshaft (A-415-7631A2) may be backfitted (as a pair, only) on Merc 20 motors, Serial No. 4403786 thru 5606491.
