NUMBER: 84-8

- A. 1984 Model 18XD and 25XD Equipped with Tiller Handle Harness and Start Button Assembly, 87-95810A2
- B. Tiller Handle Inspection/Rework - Models 35/40/50
- C. New Service Tools Available
- D. Torquing of V-6 Cylinder Head Bolts
- E. Timing Pickup Change - V-200 S/N 6537933 and Above

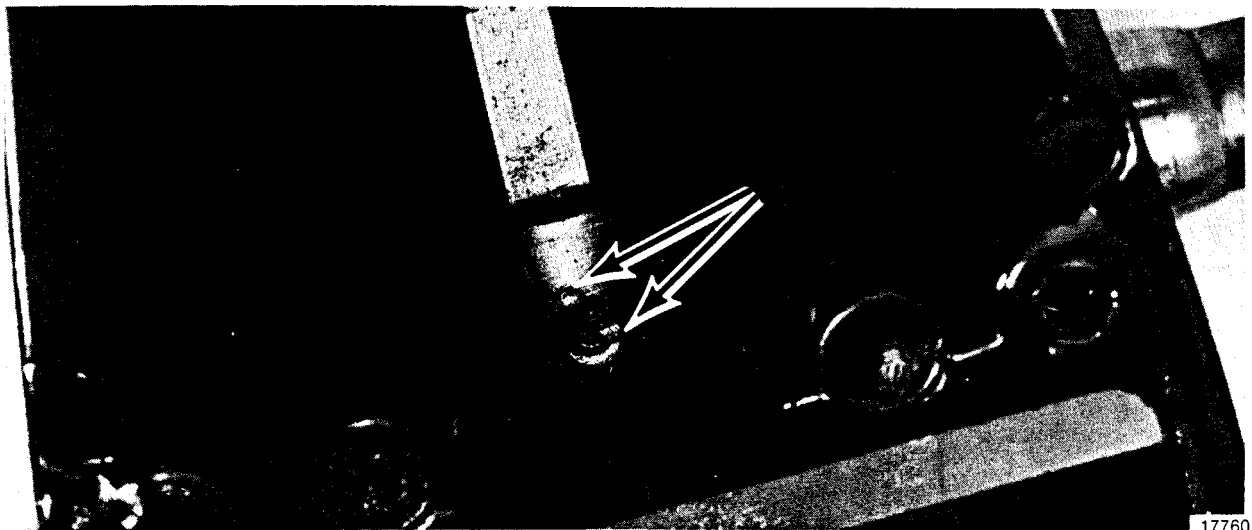
Inspect the retaining pin on the drive wheel and rod assembly. (Figure 2) The metal around the pin must be staked such that there is metal over the pin to retain it as shown in Figure 2. If the pin has not been properly staked (so as to retain the pin) use a chisel or center punch to stake pin.

NOTE: Because there is no specific orientation of the wheel and rod during assembly, there may be a percentage of the units where the pin will not face down at anytime during the rotation of the tiller handle grip. These units do not require restaking.

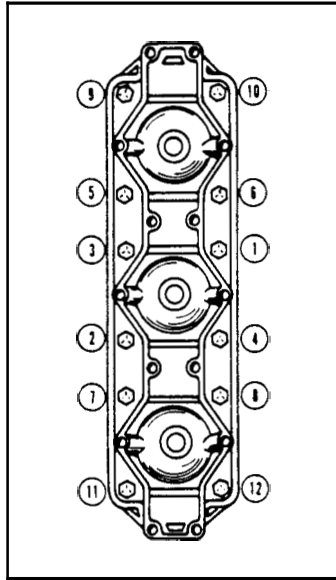
Figure 7.

Mechanics are reminded that anytime they replace a short block assembly on a V-6 outboard, it is important that the head bolts be retorqued (as shown in Figure 7) after the engine has been run approximately 3 hours. The torque setting is 40 ft. lbs. (54.2 N.m.).
