service bulletin

No. 88-16

50 & 60 HP Models – Blowing Fuses Serial Numbers 0B396036 thru 0B398982

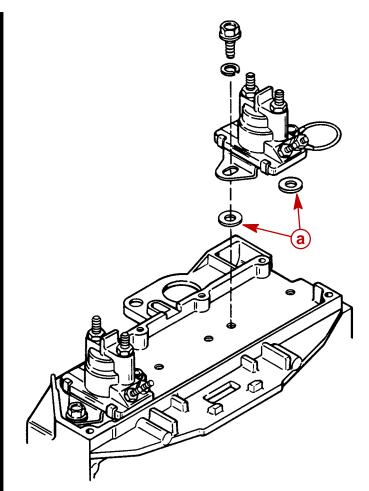
It has been determined that the solenoid terminals (on the models within the above serial number range) may contact the sound attenuator cover. If this occurs, the engine 20 amp fuse will "blow."

a - Washers

To correct this problem, place 2 washers P/N 12–26020 under each solenoid to provide additional clearance. Figure 1 (opposite side). The non–power trim models require 2 washers under the starter solenoid. The power trim models have 3 solenoids and will require a total of 6 washers.
