NOTICE

This is a revision of Outboard Service Bulletin 89-16. Destroy Bulletin 89-16 and insert Bulletin 89-16A. Revisions are underlined.

- A. Excessive Throttle Force – Mariner/Mercury 135 thru 200
- B. Carburetor ANti-Icing Kit – Mariner/Mercury 70/75/80/90 and 100/115
- C. Control Handle – Remote Control P/N 88150A7, A8, A9, A11, A15, A17
- D. Lean Idle Mixture – Mercury 275
- E. Cracked Flywheel Hub – Mariner/Mercury 250 and Mercury 275
- F. Oil Tank Vent – Mariner 40 Magnum and Mercury 40 Electric Start

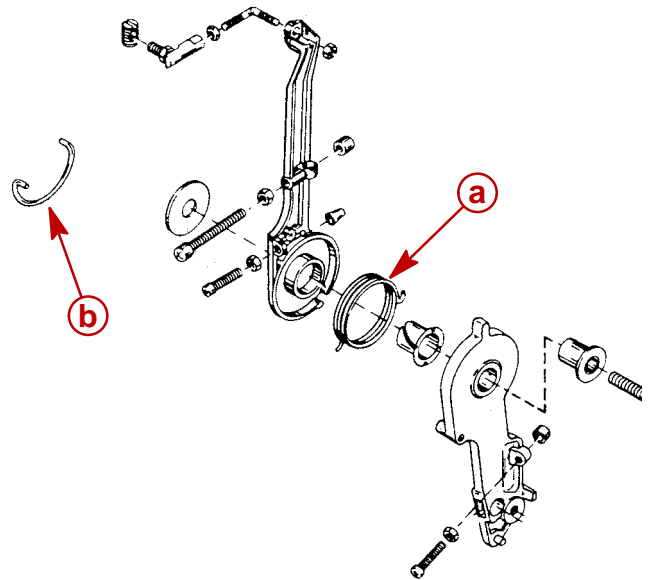
Figure 1.

A. EXCESSIVE THROTTLE FORCE – MARINER/MERCURY 135–200

When encountering excessive force to operate the throttle disconnect control cable(s) from outboard. Operate remote control to determine if outboard linkage or remote control is faulty.

On 1989 and previous Mariner and Mercury 135–200 models replace existing throttle spark lever spring with spring with less tension and remove throttle return spring (Figure 1).

24–68784 24–551 62 Throttle 'Spark Lever Spring
24–41050 Remove Throttle Return Spring

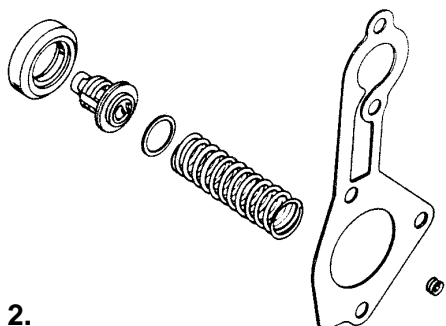
Figure 2.

**B. CARBURETOR ANTI-ICING KIT-
MARINER/MERCURY 70-90 and 100-115**

A kit to increase cylinder block temperatures and help prevent carburetor icing is available. Kit should not be installed on outboards that operate in water above 50° F (12.2°C) or overheating will occur.

P/N 75692A12 Carburetor Anti-Icing Kit

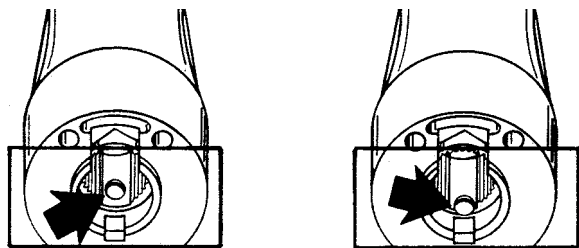
Figure 3.

**C. CONTROL HANDLE - REMOTE CONTROL
P/N 88150A7, A8, A8, A11, A15, A17**

It has been brought to our attention that the set screw which secures the handle to the center shaft of the control is pushing the handle back away from the control bezel. This may allow the handle, after a period of time, to miss the lock slot in a neutral position at the cam on the control module. When the set screw hole is drilled at the wrong angle the screw will push the handle back away from the lock ring and the handle may not lock out in the neutral gear position. If so, replace handle with a new one.

Qty 1 P/N 88314T Control Handle
One half (0.5) hour labor

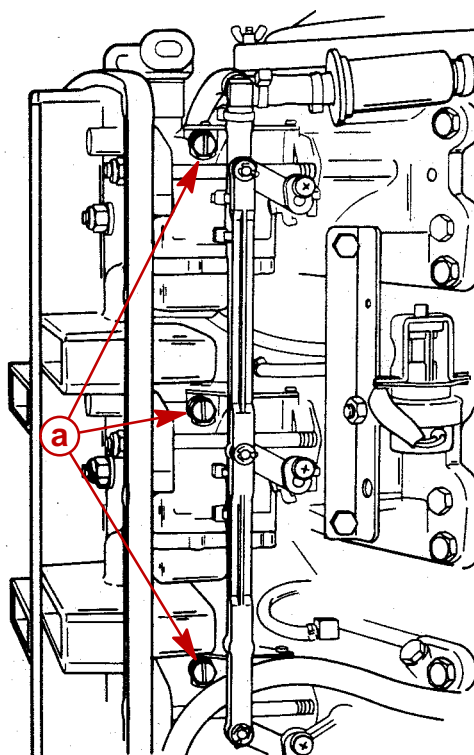
Figure 4.

D. LEAN IDLE MIXTURE - MERCURY 275

Replace existing .058 idle jets with larger .060 idle jets to correct rough idle due to lean fuel mixture. Models listed require idle jet change.

Idle jets are easily replaced on port carburetors (Figure 4) by removing access plugs. Sound attenuator plate and cover must be removed to replace idle jets on starboard carburetors.

Mark each idle jet access plug with a black mark. Idle jets have been changed in production after serial number listed and access plugs will be marked.

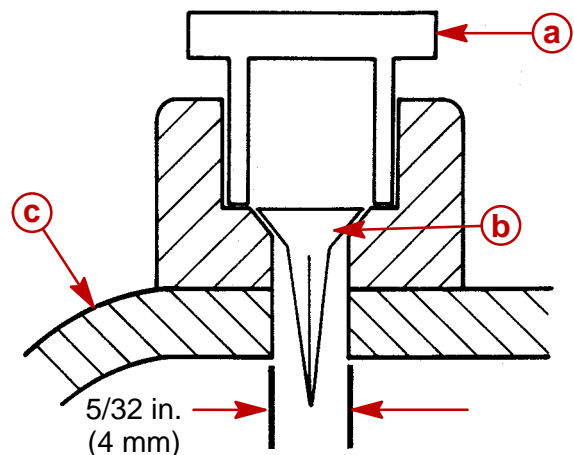
Figure 5.

F. OIL TANK VENT – MARINER 40 MAGNUM AND MERCURY 40 ELECTRIC START

Oil tank collapse during operation may be caused by vent hole that was not drilled properly on models listed.

Remove oil tank vent cap and duck bill check valve. Oil tank vent hole must have opening of 5/32 in. (4mm) diameter (Figure 5) into oil tank. A smaller opening in the oil tank vent hole may cause the duck bill check valve to not function properly. Replace oil tank if vent hole is smaller than specified.

Qty 1	P/N 1264-812778A1	Oil Tank Assembly (replacement)
One (1) hour labor or 0.3 hour labor (inspection only)
