## DETONATION CONTROL MODULE REPLACEMENT - 200 HP, EFI

1996 200 HP, EFI

S/N 0G373511 thru 0G406826

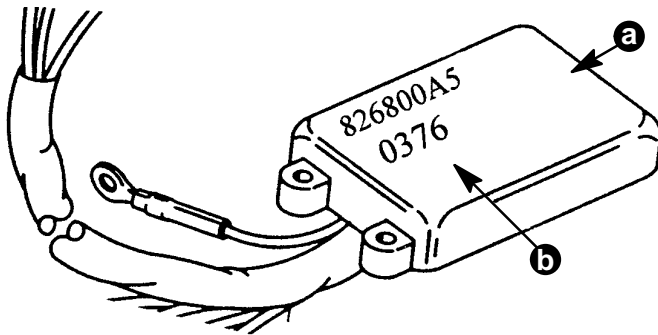
A condition has been identified that could cause a failure of the Detonation Control Module P/N 826800A8 marked 826800A5 used on 200 HP Electronic Fuel Injection (EFI) engines. Voids in the potting that surrounds the printed circuit board could cause an early failure. Failure could cause loss of timing control and inability to correct for a detonation condition.

This void has only occurred on detonation control modules using the new style textured finish plastic housing. The detonation control modules affected by this condition have date codes 3055 thru 0446. The textured finish plastic housing has a dull appearance, compared to the previous box that had a shiny/glossy finish.

a - Detonation control module  
b - Date code and part number

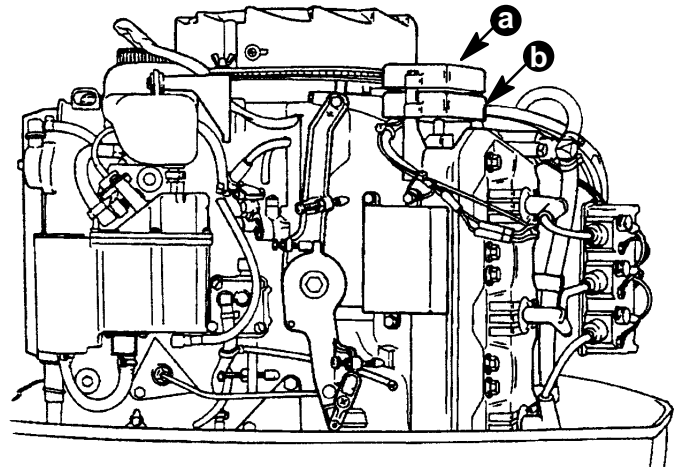
a - Detonation control module  
b - Oil injection warning module

At the top of the engine there are two modules mounted one above the other. The upper module is the detonation control. It has part number 826800A5 marked on it with white ink. If this module has a textured finish and has a date code between 3055 thru 0446, replace the module with P/N 826800A8. The replacement module will have a shiny/glossy finish with the part number 826800A5 marked on it.
