## Voltage Regulator Wire Interference – 1990 Mariner/Mercury 135-200

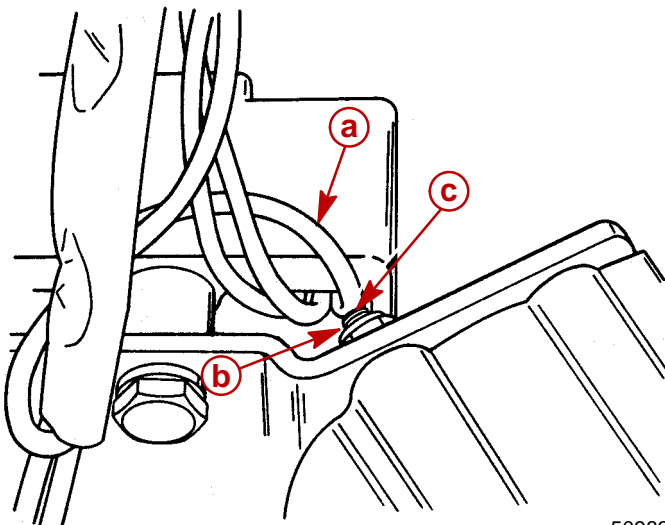
Figure 1. Wire / Screw Interface

Tachometer wire which exits the voltage regulator case may contact the ignition coil mounting screw (Figure 1) on some outboards. Wire contacts with screw end may destroy wire insulation and eventually prevent tachometer from operating.

- a** - Tachometer Wire
- b** - Ignition Coil Mounting Screw
- c** - Apply Silicone Sealer Between Wire and Screw

Check for wire and screw interference.

Move wire away from screw.

Apply a drop of silicone sealer between wire and screw (Figure 1).

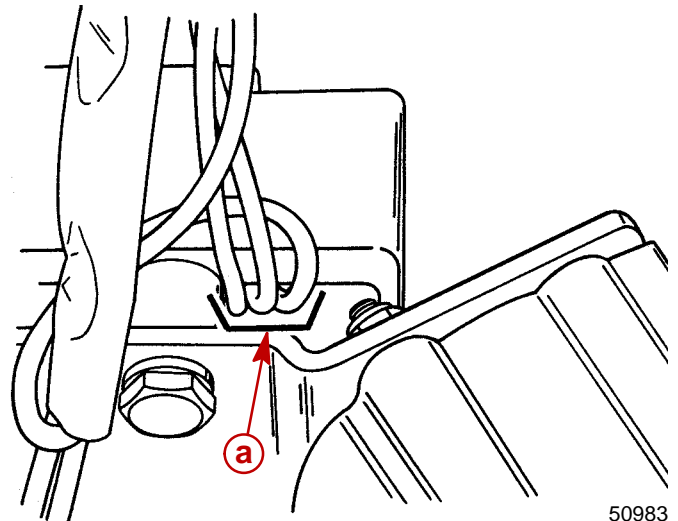
Figure 2. Voltage Regulator with 0190 Date Code

Voltage regulators produced after 1/19/90 (Julian date code 0190 printed on the housing) have the wire exit changed. These voltage regulators have the wires moved inward from the corner to an area next to the mounting hole (Figure 2).

- a** - Wire Exit Changed
