Lower End Cap Seal Improvement - 40 (4 Cyl.)

Mercury/Mariner 40 (4 Cylinder) Using Lower End Cap Assembly p/n 1158-9843A-1 (Marked 1158-9843-C). (Figure 1)

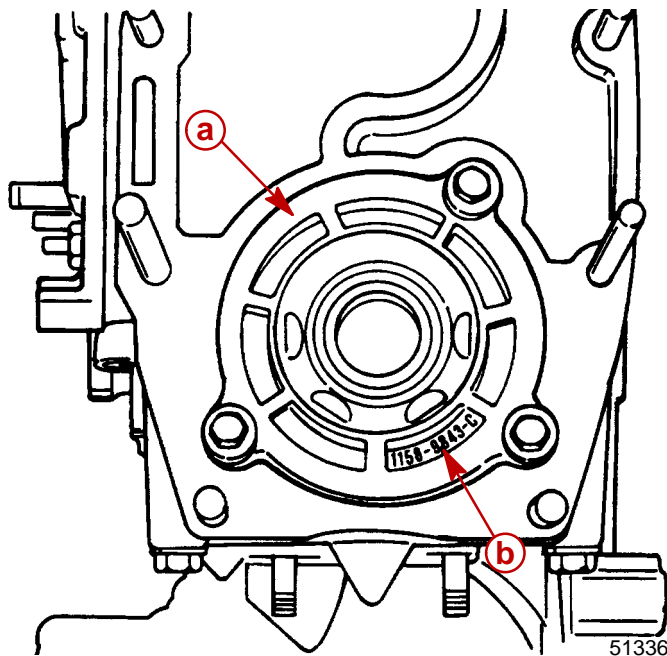
Figure 1. Lower End Cap Assembly

- a - Lower End Cap Assembly p/n 1158-9843A-1
- b - Cast Mark "1158-9843-C"

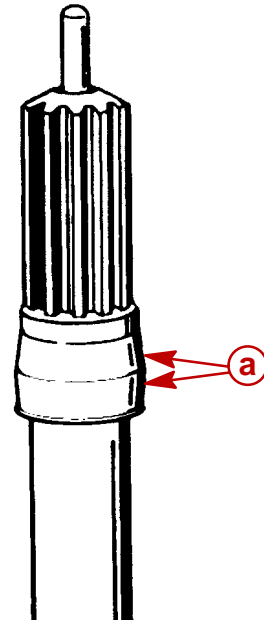
Figure 2. Previous Two Piece Seal

The crankshaft to drive shaft spline sealing design, has been improved on models listed. The previous two piece drive shaft mounted seal p/n 813107A-1 (Figure 2), has been superseded to a carrier/seal assembly p/n 60834A-3 (Figure 3), which is installed into the end of the crankshaft.

- a - Two-Piece Seal (Discard)

1. Remove powerhead as outlined in service manual.
2. Remove (and discard) existing two piece seal assembly from splines of drive shaft.

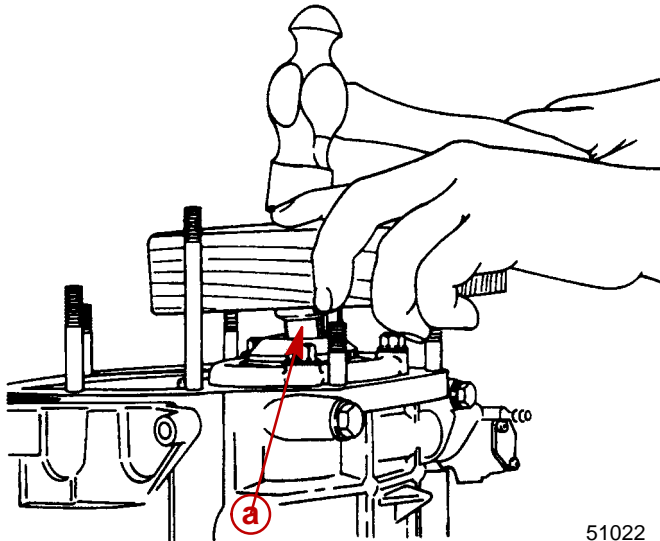
Figure 3. Carrier/Seal Installation

a - Carrier/Seal Assembly

1. Thoroughly clean crank shaft splines with solvent and dry with compressed air.
2. Drive carrier/seal assembly into end of crankshaft, using a block of wood to protect carrier.

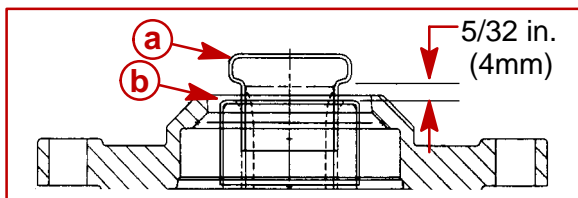
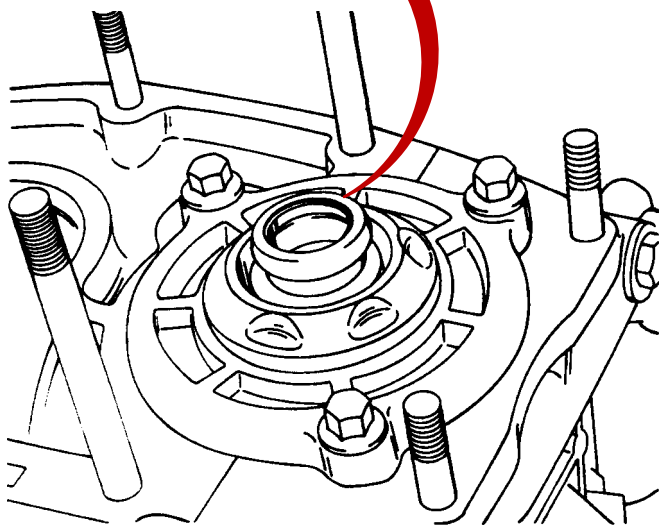
Figure 4. Carrier Installed

a - Carrier/Seal Assembly

b - End of Crankshaft

3. Carrier should be driven squarely into crankshaft, until clearance between head of carrier and end of crankshaft is approximately 5/32 in. (4mm).

4. Apply Special Lubricant 101 (p/n 92-13872A-1) to splines of drive shaft. DO NOT apply grease to top of drive shaft, as this could prevent drive shaft from fully engaging crankshaft.
5. Reinstall powerhead onto drive shaft housing, as outlined in service manual. Torque powerhead attaching nuts to 150 lb. in. (17 Nm).
