Reversed Steering Control Cables – Thruster R33 and R45 Models

This is a revision of Outboard Service Bulletin 90-13. Destroy Bulletin 90-13 and insert Bulletin 90-13A. Revisions are underlined.

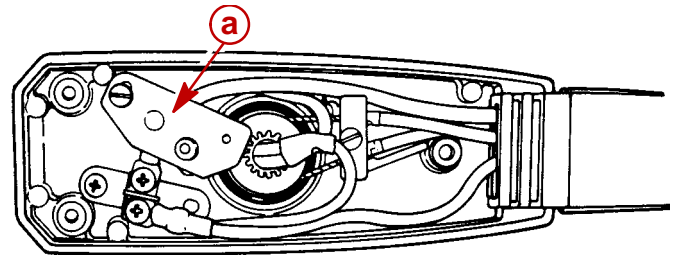
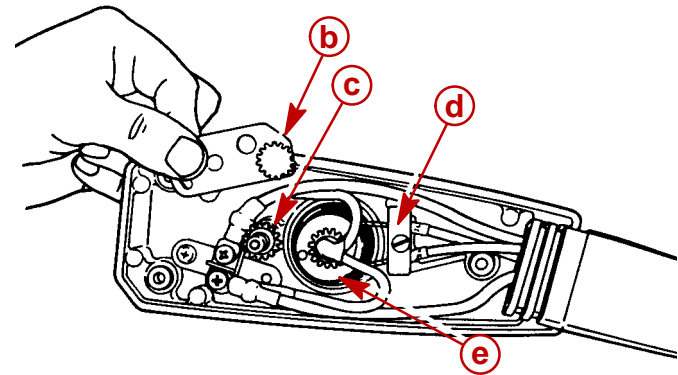
- a - Retainer Plate
- b - Idler Gear
- c - Direction Indicator Gear
- d - Cable Retainer
- e - Cable Drum

1. Remove direction indicator and control housing cover.
2. Remove retainer plate, idler gear and direction indicator gear.
3. Remove cable retainer and lift cable drum off vertical shaft.

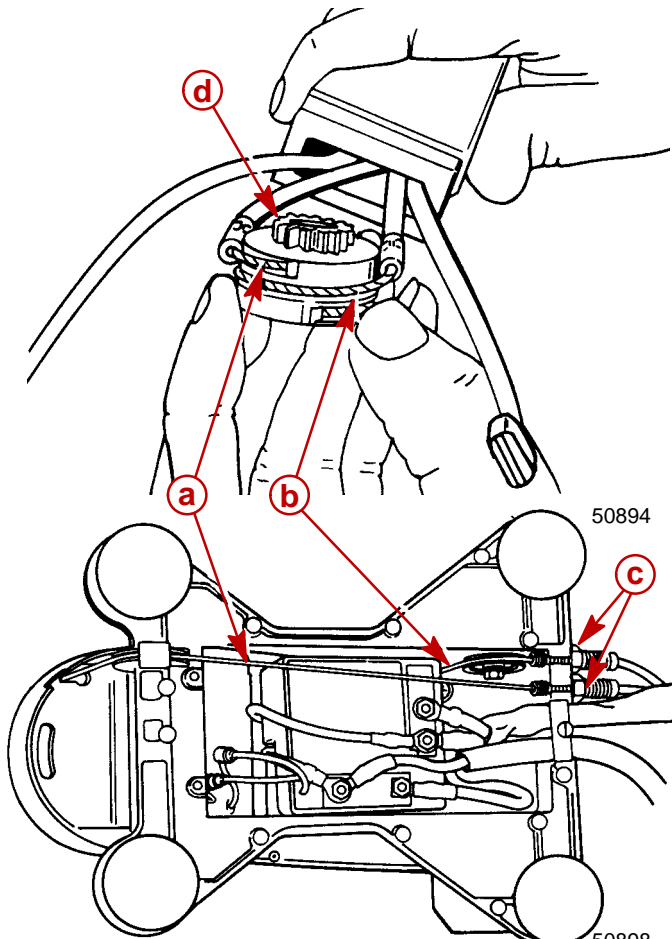
- a** - Control Cable (extends to heel of foot control plate) - Insert ball of cable into top socket on cable drum and wrap cable clockwise around drum
- b** - Control Cable (extends to toe of foot control plate) - Insert ball of cable into bottom socket on cable drum and wrap cable counterclockwise around drum
- c** - Adjustment Nuts
- d** - Cable Drum

- Thread adjustment nuts all the way up on control cables.
- Reinstall control cables around cable drum as shown.

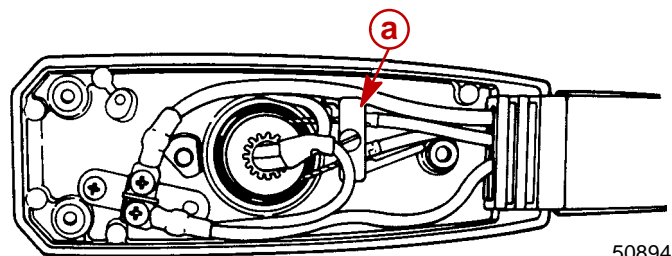
- a** - Cable Retainer

- Position motor in desired direction vs. desired angle of foot pedal. Place cable drum on vertical shaft and secure cable ends with cable retainer.

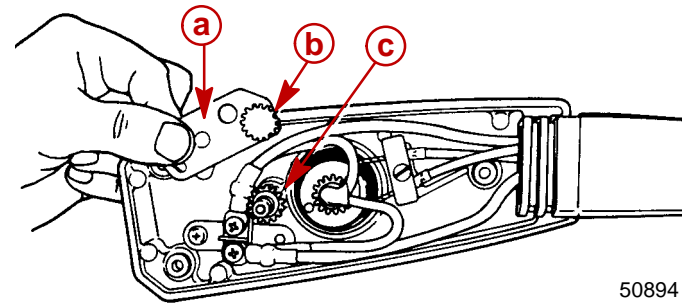
- a** - Retainer Plate
- b** - Idler Gear
- c** - Direction Indicator Gear

- Reinstall direction indicator gear, idler gear and retainer plate.

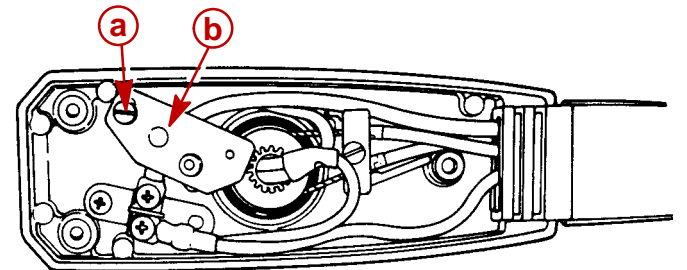
- a** - Screw
- b** - Retainer Plate

- Adjust retainer plate so gears turn smoothly.

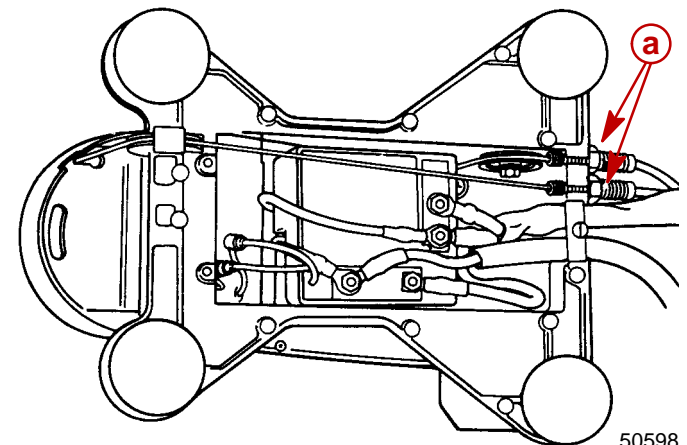
- a** - Adjustment Nuts

- Use adjustment nuts to remove cable slack.
