Throttle Cam Change - 100/115 Models

Mariner and Mercury 100 and 115 4 cylinder

Belgium 09523034 - 09646675
Canada 0A731673 and above
US 0B209468 - 0D028564

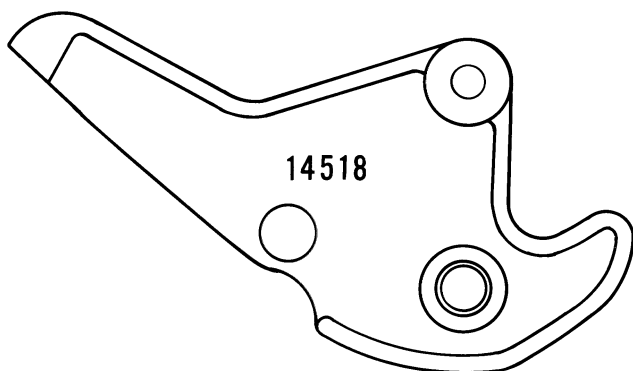
Figure 1. Previous Throttle Cam P/N 14518T

A change has been made to the throttle cam material to prevent the possibility of the throttle cam sticking. The previous throttle cam p/n 14518T (stamped 14518) and the stem of the accelerator pump plunger are made from the same material. This material has good bonding properties when in contact with itself and subjected to vibration. As a result, the throttle cam and accelerator pump plunger stem may bond together requiring extra force to move the throttle in a stuck throttle situation. Bonding does not occur with the presence of grease between these parts which is applied during assembly.

Install a new throttle cam p/n 14518T--1 when servicing any 100/115 model listed that has a previous throttle cam. Previous throttle cam had 14518 printed on it. New throttle cam has 14518-C3 printed on it.
