Friction Nut Assembly-Co-Pilot P/N 11-52155A1 Increased Friction Holding Capacity

All Mercury and Mariner tiller handle models equipped with a Co-Pilot Kit.

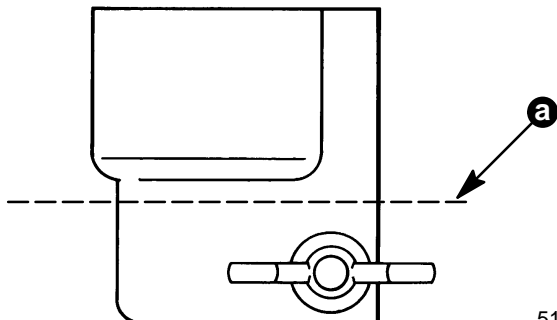
a - Cut-Stop Before Reaching Center

Remove the friction nut assembly P/N 11-52155A1 from the co-pilot assembly. Remove the bolt and wingnut from the friction nut housing. Using a hacksaw, line the hacksaw blade up on the friction nut housing as shown in Figure 1. Cut the friction nut housing no more than halfway through as shown in Figure 2. Reassemble co-pilot assembly.

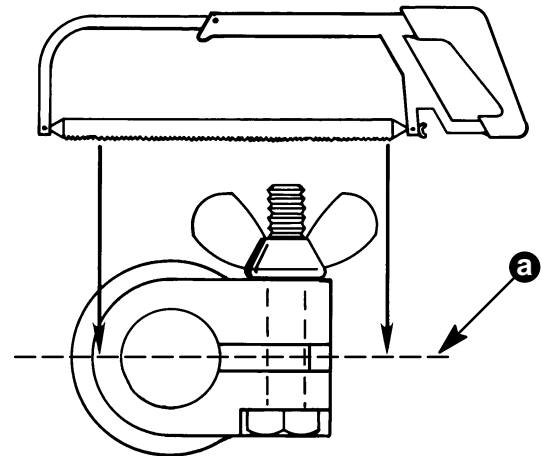
Figure 2.

a - Do Not Cut More Than Halfway

If nut is inadvertently cut more than 1/2 way, the nut must be discarded and not used.
