## Top Cowl Unlatching – 1989-1991 135 thru 200

**MARINER AND MERCURY**  
**135-200**  
**S/N 0C100861-0D038616**

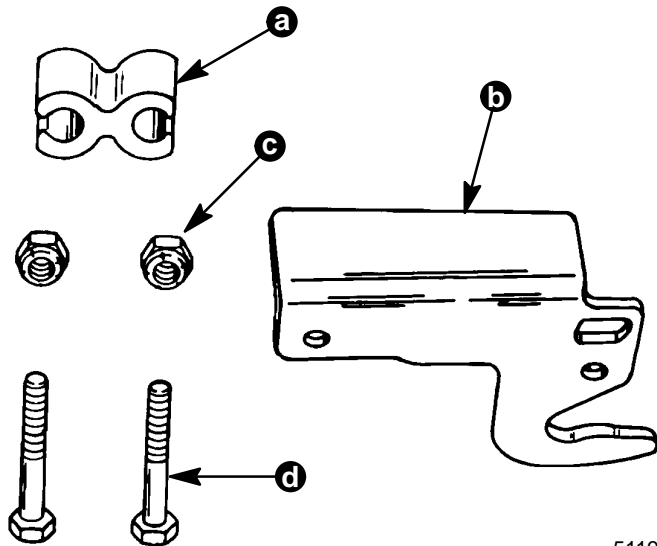
51192

- a - Special Spacer
- b - Handle/Latch P/N 813076--3
- c - Lock Nut (2)
- d - Screw (2)

Outboard operation on extremely rough water may cause the front handle/latch to deform and not retain the top cowl as designed. To prevent the top cowl from unlatching, install Handle/Latch Kit P/N 813076A-2. The kit contains an improved (straight) front handle/latch P/N 813076--3, a special spacer for the roller assembly, fasteners and installation instructions. Also refer to service bulletin 90-4 for rear cowl latch changes for early models.
