Crankshaft Sealing Ring Change – 1991 135 thru 200

MERCURY/MARINER

135-175 S/N 0D050182 and above
 200 (2.5L) S/N 0C291520 and above

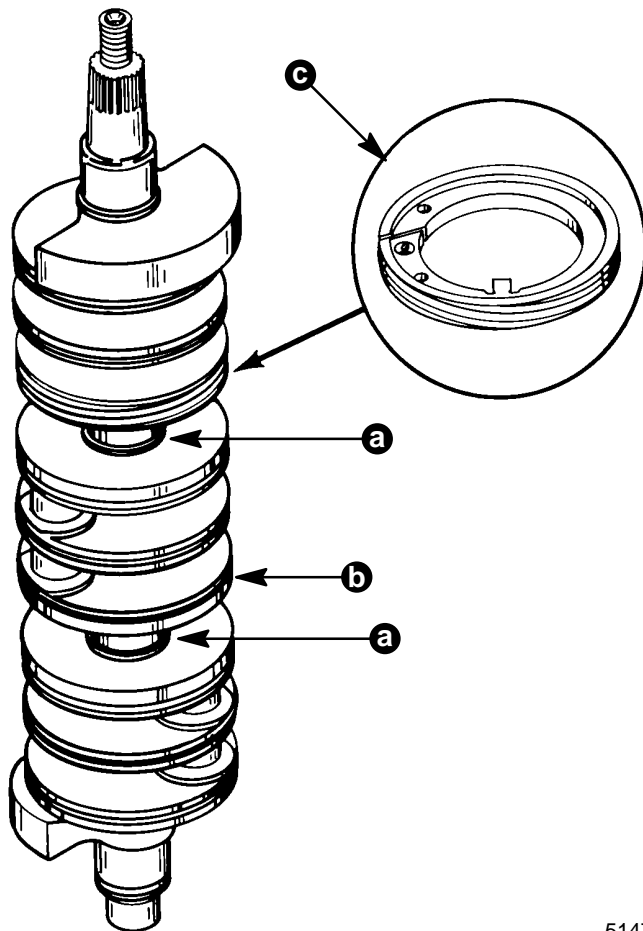
51478

Beginning with serial number listed, the sealing ring groove in the crankshaft above the lower center main bearing has also been eliminated.

- a - Center Main Bearings
- b - Sealing ring groove above lower center main bearing.
- c - Oil Injection Gear

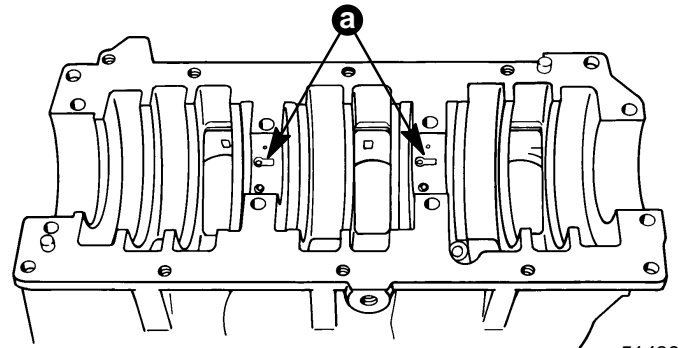
51439

The crankshaft seal ring above the lower center main bearing and the drilled passages in the cylinder block to both center main bearings were deleted beginning with the serial numbers listed above.

a - Drilled passages to center main bearings

When reassembling a powerhead using a cylinder block that has drilled passages to the center main bearings, either crankshaft (with or without the sealing ring above lower center main bearing) may be used.

When reassembling a powerhead using a cylinder block that does not have the drilled passages to center main bearings, a crankshaft without the ring above the lower center main bearing must be used. **DO NOT** install a crankshaft with a sealing ring above the center main bearing.

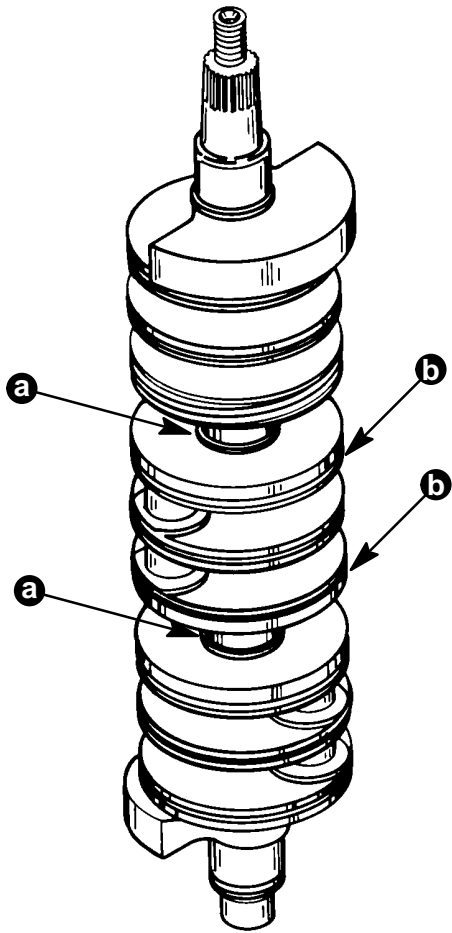
51478

NOTE: Hi-Performance crankshafts do not have an oil injection gear above the upper main bearing. Consequently the sealing ring grooves above both the upper and lower main bearings have been eliminated.

a - Center Main Bearings

b - Sealing Ring Grooves Above Center Main Bearings
