No. 92-19

# **Trigger Modification - 250/275**

Mariner and Mercury

250/275 Models

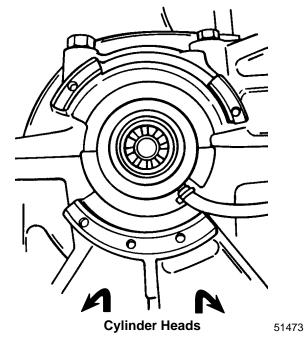
### FIGURE 5. TOP VIEW OF CYLINDER BLOCK

When servicing a 250 or 275 with the new upper crankshaft bearing with the bleed fitting, the bleed line sta-strap locking tab must be turned towards the rear of the engine to provide clearance for the trigger arm (Figure 5).

a - Sta-Strap Locking Tab
