service bulletin

No. 94-10

Power Trim Shaft Not Engaging Sender - 75 thru 125

Mariner and Mercury

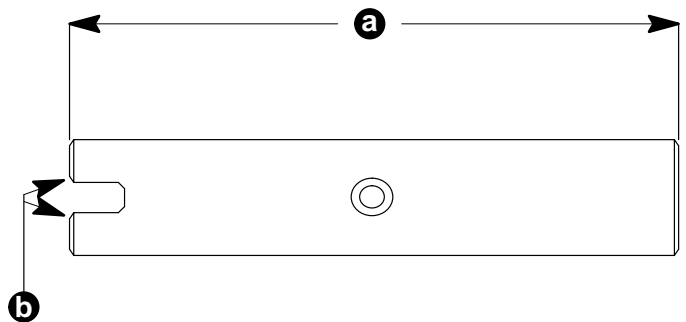
Figure 1. 99625--1 Pivot Shaft.

The power trim upper slotted pivot shaft may not totally engage the power trim gauge sender. The trim gauge may operate for a period of time and then quit.

The new pivot shaft p/n 99625--1 is installed on late 1994 75 thru 125 models beginning after the serial numbers listed and supersedes the previous pivot shaft p/n 99625. The new shaft is slightly longer and does not have the chamfer at the outer end of the slot.

a - Slightly Longer.

b - Chamfer Removed.

If the pivot shaft does not engage the sender, install the new slotted pivot shaft p/n 99625--1.

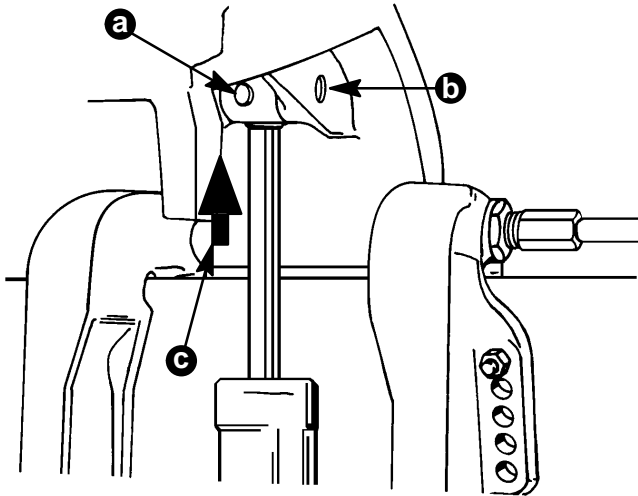
Figure 2. Shim Washer Location.

- a - Cross Pin.
- b - Upper Pivot Shaft.
- c - Install Washer(s).

In an emergency, shim the power trim rod eye over toward the starboard side using the washers listed.

Remove the cross pin and the upper pivot shaft. Install 0.125 inch (3 mm) washer(s) listed between the port side of the power trim rod eye and the swivel bracket. Reinstall the upper pivot shaft and the cross pin.
