Exhaust Manifold Bolts - Sport Jet 120

MODELS AFFECTED:

1995 Sport Jet 120
S/N 0E093700 thru 0E125508

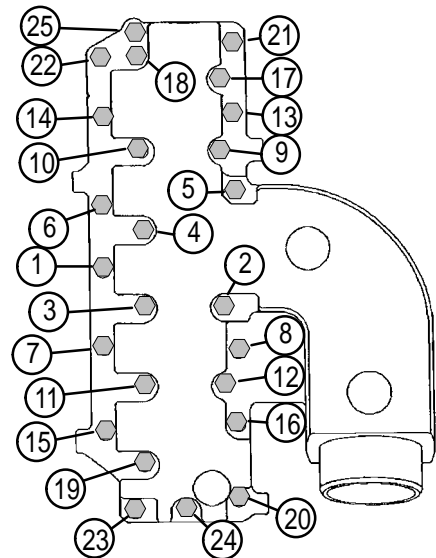
Figure 1

We are receiving sporadic reports from the field on Sport Jet 120's that have leaked water at cylinder and exhaust manifold parting line.

Investigation of this problem revealed reduced (low) clamp load on exhaust manifold gasket. This is caused by initial thermocycling of powerhead which reduced torque of stainless steel bolts.

NOTE: It is very important to oil bolt threads and underside of head prior to installation to achieve proper and uniform clamp load.

1. Remove bolt #1 per Figure 1. Install new bolt and existing washer. Torque bolt to 115 lb/in (13.0 N·m). Then, follow same procedure for bolt #2 and so on until all bolts have been replaced and torqued following the sequence in Figure 1.

NOTE: Replacement of the exhaust gasket is not necessary when using this procedure.

2. After all bolts have been replaced and torqued, retorque bolts #1 thru #8 (center bolts) per Figure 1.
