Revised 7-14-97

## Special Adjustment for Stator Failures - 75 thru 125, Sport Jet 90/120

This is a revision of Service Bulletin 97-4. Destroy Bulletin 97-4 and insert this revised Bulletin 97-4 7-14-97. Changes are underlined.

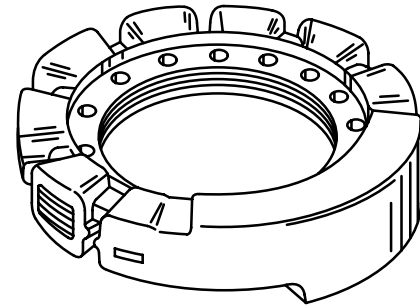
The above listed models have experienced a higher than normal incidence of stator failures. The “red” stator was introduced with design improvements for increased reliability and durability. These models were manufactured prior to the installation of the red stator. If a stator failure occurs within the affected serial number range, Mercury Marine will cover parts and labor for three years from the original outboard date of sale. This applies to first and second owners. The bill of sale must be provided if the consumer is not the registered owner. Both pleasure and commercial use will be covered.

Failures of Quicksilver replacement stators purchased for use on the above listed models will be covered for three years from the replacement stator date of sale. Submit a paper warranty claim with a dated receipt of the failed stator.
