## Adapter Plate Improvements - 3.0 Litre V6

### Models Affected

1994 thru 1996, 3.0 Litre V6  
S/N 0D280813 thru 0G437999

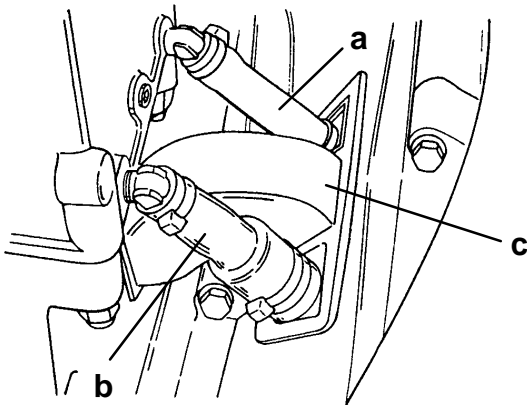
Idle exhaust boot melting, and/or cracking of the exhaust adapter plate. First indication of this condition is a louder exhaust noise at idle speed.

If condition 1 is suspected, inspect the idle exhaust boot for a charred or burned appearance. If burned, remove exhaust boot from the adapter plate and inspect for a crack in the adapter plate.

- a - Tell-Tale Hose
- b - Flush Hose
- c - Idle Exhaust Boot

If the idle exhaust boot is burned, an Exhaust Adapter Plate Cooling Kit (850435A1) should be installed. If the exhaust plate is cracked, it should be replaced with a new Adapter Plate (818450A2) and an Exhaust Adapter Plate Cooling Kit (850435A1). The cooling kit will take water from the tell tale discharge hose and direct it into the rear chamber of the adapter plate, lowering the temperature of the plate and exhaust boot.

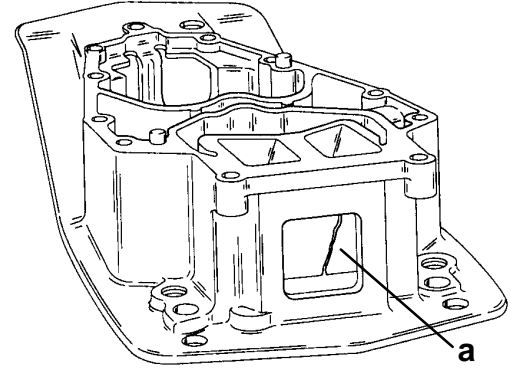
a - Crack In Exhaust Adapter Plate

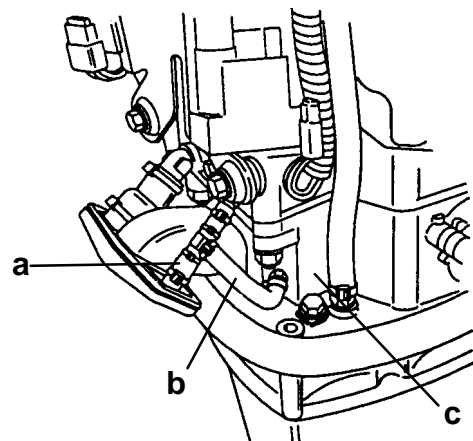
- a - Tell-Tale Hose
- b - Cooling Kit Hose
- c - Exhaust Adapter Plate

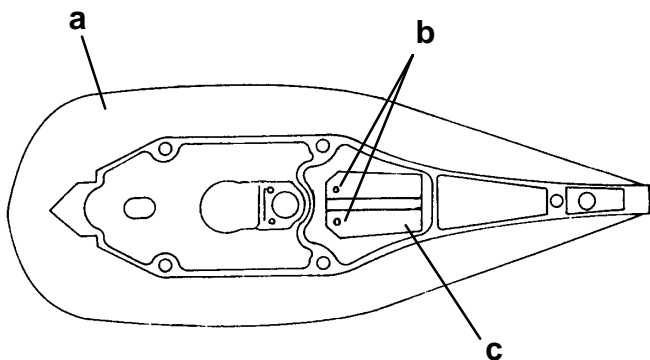
Plugged water discharge holes in adapter plate. This condition should be suspected when the customer reports repeated failures of the propeller hub within a short period of time, or if the bearing carrier seals look charred or burned.

The exhaust gases that exit the engine are cooled by water that enters the exhaust system at the adapter plate. If condition 2 is suspected it is likely that the water discharge holes are blocked with debris. To inspect discharge holes first remove the lower unit. Then using a light, look up the exhaust tube. If the two discharge holes are blocked they must be cleared. In most cases it is not necessary to remove the powerhead to clear the discharge holes.

- a - Bottom View Driveshaft Housing
- b - Water Discharge Holes
- c - Exhaust Tube

Exhaust system water discharge holes in most cases can be cleared by using a # 39 (2.5mm) drill bit on the end of a 2 ft. long 3/8" dia. iron rod. A hole can be drilled into the end of the rod using a #39 drill bit. Then install the #39 drill bit into the hole drilled in the rod. Drill bit can be retained into rod by brazing or with a set screw. Using the rod/drill bit assembly go up through the exhaust tube and clear out debris from discharge holes. Then flush out the cooling system as outlined in the Operation and Maintenance Manual. Regular flushing of the cooling system will help keep the discharge holes clear.

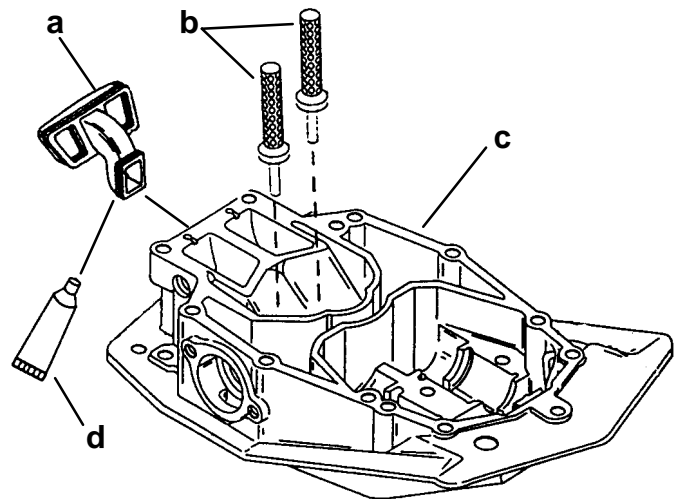
- a - Idle Exhaust Boot
- b - Strainer Screens (Water Discharge)
- c - Exhaust Adapter Plate
- d - Glue (3M #3M08155, obtain locally)

If regular flushing of cooling system fails to keep holes clear, it is recommended to install a new Adapter Plate (818450A2), that has strainer screens installed above the discharge holes to prevent blockage.

**NOTE:** Strainer screens can not be added to existing adapter plate due to a casting change.
