service bulletin

No. 98-14

Official Notification Federal Boat Safety Act Upper Motor Mount Replacement - 9.9/15 (4-Stroke)

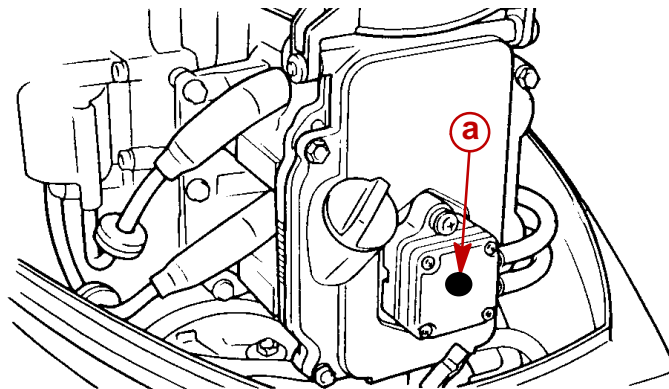
a - Black Dot Sticker

- A black dot sticker applied on the outboard serial number label of the shipping carton.
- A black dot sticker applied on the fuel pump cover.
- Use MIDAS - Product History, to determine if this fix campaign 1998-014 is "OPEN" or has been "COMPLETED".

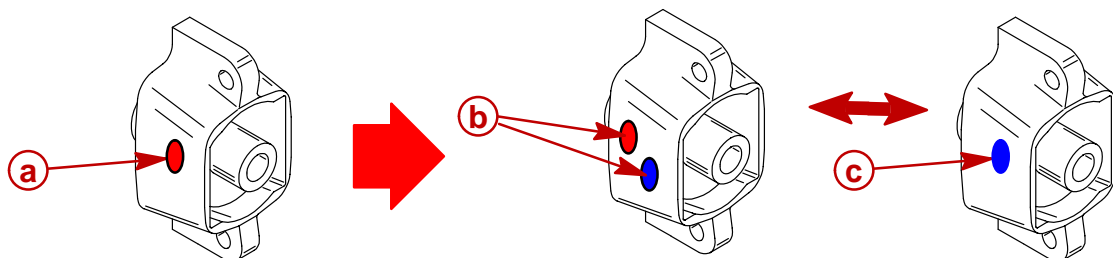
The new replacement upper motor mounts are identified by both a blue and a red or a single blue paint dot located on the driveshaft housing side of each motor mount housing.

a - Mount with single red paint dot - **MUST** be replaced (p/n 835410)

b - Mount with both a red and a blue dot - good mount (p/n 835410T)

c - Mount with single blue dot - good mount (p/n 835410T)

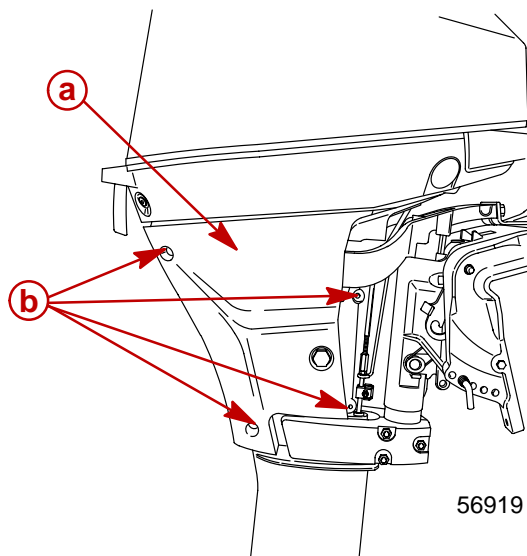
a - Driveshaft Housing Covers

b - Bolts (4), Nuts (4)

1. Remove driveshaft housing covers (4 bolts and nuts).

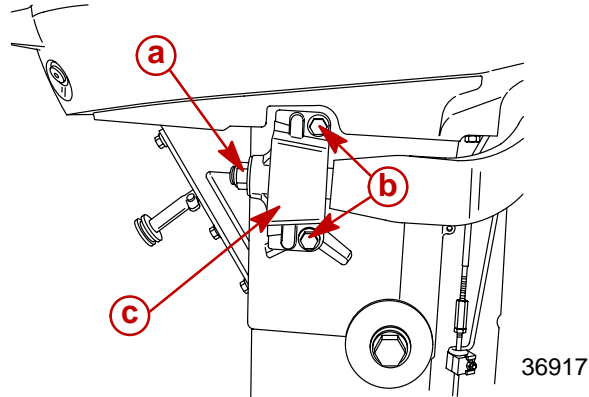
- a** - Nut and Washer
- b** - Bolts (2)
- c** - Upper Mount

2. Remove two (2) bolts (M8x.98) from upper mount.
3. Remove nut and washer from swivel head stud.

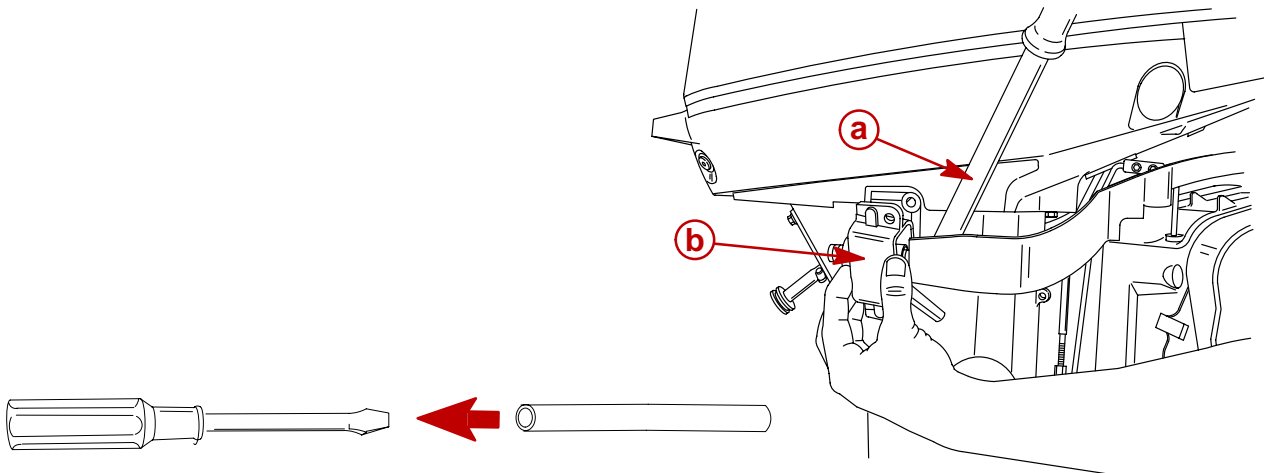
- a** - Rubber Padded Bar
- b** - Mount

4. Slide a piece of rubber hose over a screwdriver to prevent paint damage on outboard components. Pry up on lower cowl pan. Slide mount off of stud.

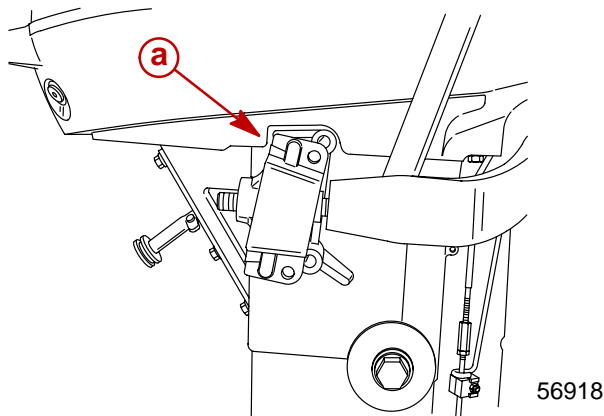
- a** - Lip on Lower Cowl Pan

5. Pry up on lower cowl pan to slide new mount over stud just enough to pass over top lip on lower cowl pan. Remove pry bar. Push down on top of outboard (to seat mount). Mount should align into place.

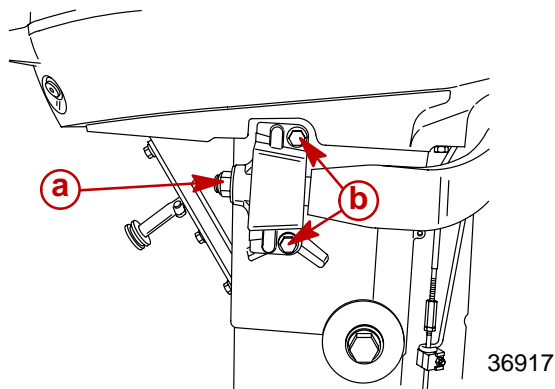
- a** - Nut and Washer - Torque to 32.5 lb. ft. (44 N-m)
- b** - Bolts (2) Torque to 15 lb. ft. (20.3 N-m)

6. First replace two (2) bolts (M8x.98) into mount and then replace washer and nut.
7. Torque two (2) bolts to 15 lb. ft. (20.3 N-m).
8. Torque nut to 32.5 lb. ft. (44 N-m).

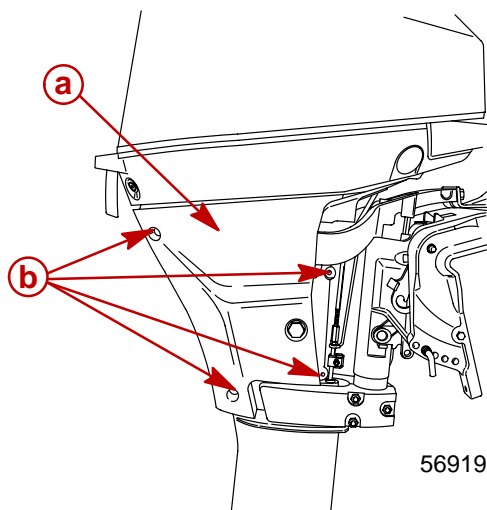
- a** - Driveshaft Housing Covers
- b** - Bolts (4), Nuts (4) Torque Bolts and Nuts to 30 lb-in. (3.4 Nm)

9. Install driveshaft housing covers (4 bolts and nuts).
