## Ground - Ignition Plate

### Models Affected

Force 75, 90 & 120 HP - 1996 thru 1998  
Serial Number - 0E138600 thru 0E329500

Sport Jet 95XR/120XR - 1996 thru 1998  
Serial Number - 0E141089 thru 0E329500

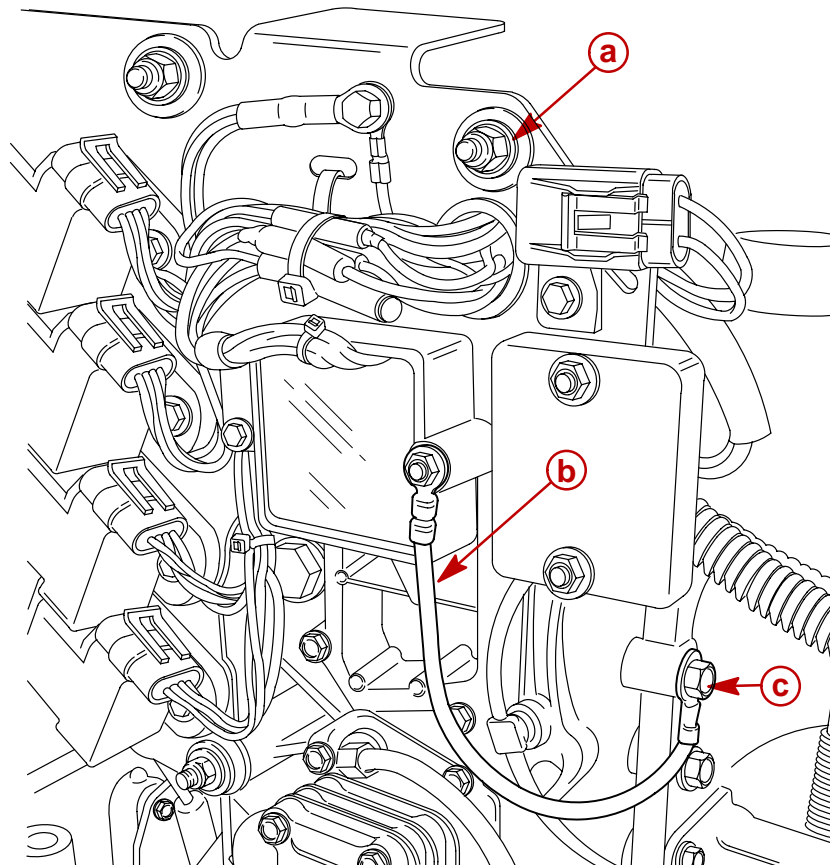
57211

A poor ground connection from the ignition components plate to the engine block can cause a voltage regulator and/or multiple CDM failures.

- a** - Old Ground Connection
- b** - New Ground Wire
- c** - New Ground Connection

To ensure a good ground connection, a new ground wire and routing has been developed. This was incorporated as a running change during the 1998 model year and can be applied to the engines within the serial number range listed above. The figure below indicates the proper routing of the ground wire.

The part number of the ground wire is: 84-856583A1

**IMPORTANT: Remove the original ground wire (voltage regulator to ignition component plate stud) before attaching the new ground wire. This ensures proper thread engagement of the screw.**
