service bulletin

No. 98-13

Official Notification Federal Boat Safety Act Reverse Lock Link Rod Replacement - 15 (4-Stroke)

1998 15 (4-Stroke) USA S/N 0G590000 thru 0G736819

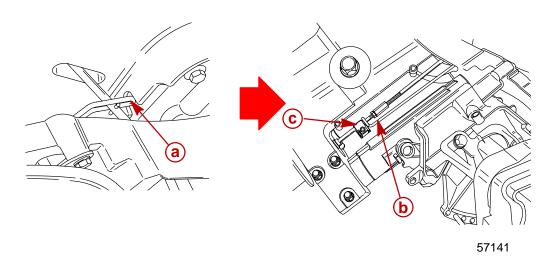
Outboards listed require replacement of the reverse lock link rod prior to operation. Affected units were assembled with reverse lock link rods which can come in contact with the lower cowl pan and deflect (bend) out of adjustment. This misadjustment can engage the reverse lock hooks in forward gear and not allow the outboard to be tilted up. Should the lower unit strike a submerged object while the boat is in forward gear, this condition could cause damage to the reverse lock mechanism and/or at slower boat speeds result in a sudden unexpected boat stoppage.

- a Upper Reverse Lock Link Rod Early design (actuated by a cross pin) making contact with lower cowl.
- Reverse Lock Link Rod Kit (p/n 858338A3) Current design, actuated by reverse hook guide.
- c Reverse Hook Guide

Replace the existing reverse link rod assembly, as outlined in the installation instructions supplied with Reverse Lock Link Rod Kit (p/n 858338A3).
