service information

No. 99-9

Gearcase Sleeve 41121 - 9.9/15 (4S) & 20/25 (2S)

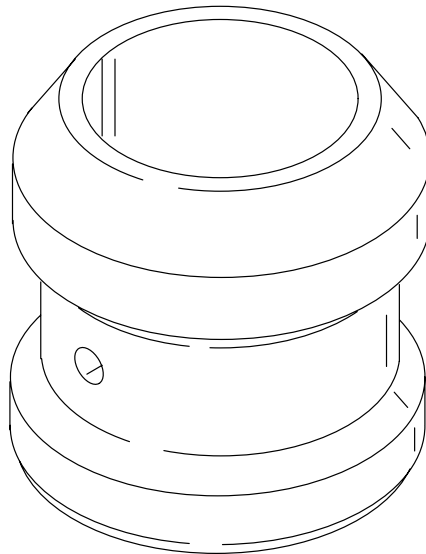
P/N 41121 Sleeve

A replacement sleeve p/n 41121 for the gear housing is now available for the models listed. The sleeve is located in the gear housing below the water pump and retains the upper drive-shaft needle bearing and oil seals. Replacement may be required if it becomes corroded or damaged. Removal is difficult without proper tools. It is important to follow the procedures outlined in this advisory. Installation of the new sleeve requires the application of Loctite 271. Sufficient time for a complete cure of the Loctite is also essential.
