# service information

ADVISORY

No. 99-10

## Tilt Release – Big Foot 50 (4S) & 60 (2S)

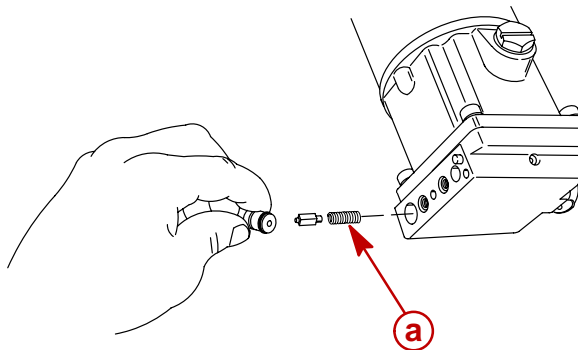
**Power Trim with Cylinder Removed**

Some customers with big foot models have become concerned when they can easily push their unit down by hand from the full tilt position. This is usually experienced on dry land while cleaning or servicing. The design of the power trim allows this to occur mostly due to the geometry of the tilt system, internal valving, and the additional weight of the big foot gear-case. Complete power trim units have been replaced in an attempt to “fix” the problem, without success. The power trim is operating as designed.

**a** - Tilt Release Spring

The tilt relief spring color is also changed from the previous plain steel (dark) color to the new silver (galvanized) color. The new spring is also contained in the Trim Limit Valve Kits 809873A2 with date on or after 27 Aug 98.

Outboards after the serial numbers listed have the new stronger power trim tilt release spring p/n 24-804849 to prevent the “easy tilt down” from occurring as a product improvement. Customers may have the new inexpensive tilt release spring installed, at their own expense, if they desire. Labor to install the new spring is approximately one hour.

Replace the existing dark colored tilt release spring in the power trim manifold with a new silver spring p/n 24-804849.
