ADVISORY
 BULLETIN

No. 99-11

Vapor Separator Cover (VST) – Fitting

MERCURY/MARINER
150/175/200 HP, EFI
S/N 0G826701 Thru 0G927574

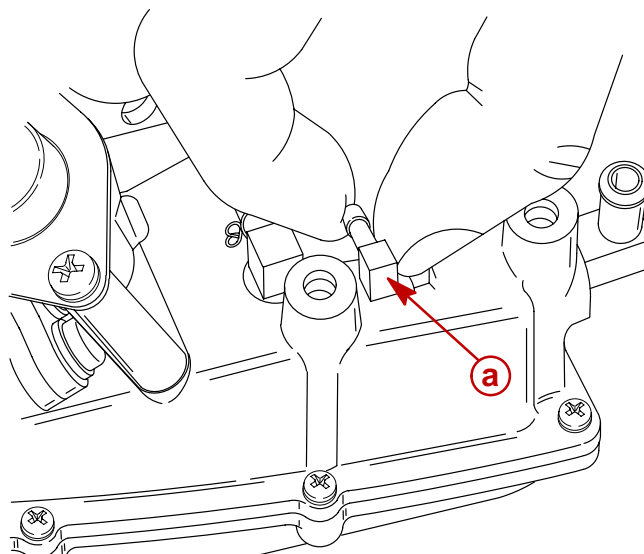
57753

An inaccurate manufacturing process of the bleed return hose fitting on the top cover of the Vapor Separator Tank (VST) may cause the fitting to be loose. This is a pressed in elbow fitting that allows re-circulated oil/fuel from the reed block area to enter the VST. The fitting should be checked for looseness and replaced if necessary.

If the outboard is within the above serial number range and does NOT have the factory rework markings on the engine carton or engine, check the fitting for tightness. Remove the bleed return hose from the fitting, and by hand using moderate pressure try to twist the fitting in the VST cover. If the fitting can be turned by hand, it should be replaced with fitting **P/N 22 – 877324**.

a - Elbow Fitting

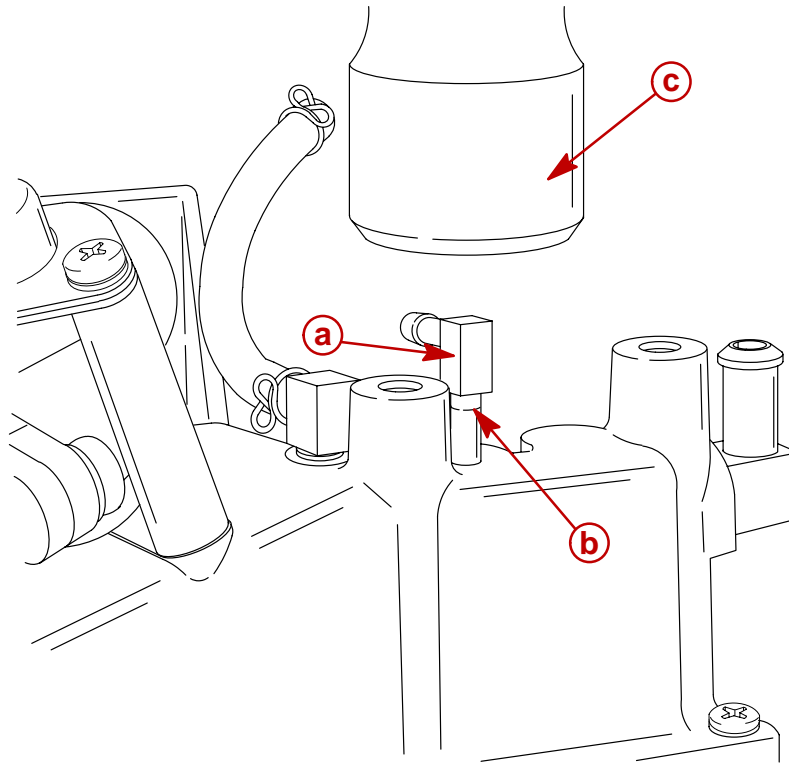
57754

- a** - Elbow fitting
- b** - Serrated portion
- c** - Hammer

If the fitting is found to be loose, remove the old fitting. Install new fitting **P/N 22 – 877324** by carefully using a hammer to drive it into the VST cover. The fitting should be installed with the serrated portion facing down toward the cover. Check the new fitting for tightness, reinstall the bleed line, and mark a WHITE dot on the side of the VST.
