Flo-Torq II Hub Kit (Thrust Washer Taper)

Revised December 2007. This bulletin supersedes the previous bulletin number 2006-12 August 2006.

Models Affected

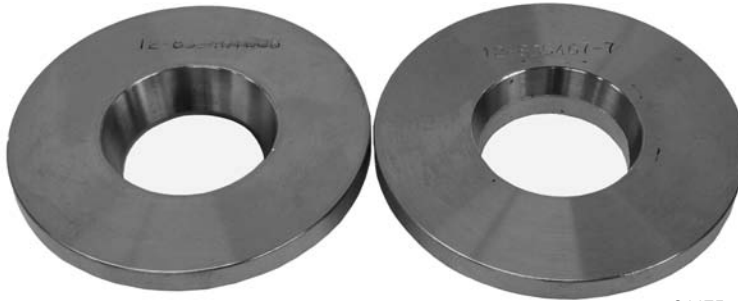
Mercury Marine offers a diverse line of propeller hardware and accessories. The above hub kits for installing Mercury/Quicksilver propellers may contain the wrong forward thrust washer P/N 12-835467008. This thrust washer allows the propeller to be positioned too far forward on the prop shaft. When using this washer, the propeller may rub on the gearcase, and/or the propeller nut may bottom out the end of the threaded section before the propeller tightens on the propeller aft adapter.

NOTE: The two different thrust washers look very similar with the only difference being the depth in which the taper is machined. The taper on P/N 12-835467008 is almost all the way through the washer and the taper on P/N 12-835467 7 is about halfway through the washer.

P/N 12-835467008 with full taper on ID

P/N 12-835467 7 with half taper on ID

The installer must check for free movement of the propeller in neutral, and check to ensure the propeller is tight on the prop shaft after installation of the Flo-Torq II hub kit. If contact occurs, or if the nut bottoms out before the propeller is tight on the shaft, the thrust washer should be replaced with P/N 12-835467 7.

Date codes prior to June 29, 2006 should be inspected for the correct washer. If the washer is incorrect, replace with the correct P/N 12-835467 7.
