ADVISORY  
 BULLETIN

No. 2000-10  
(Mercury Jet Drives No. 2000-01)

## Oil Pump Coupler/Bearing – Sport Jet 175

175HP Sport Jets: 1997, 1998, 1999 Model year product

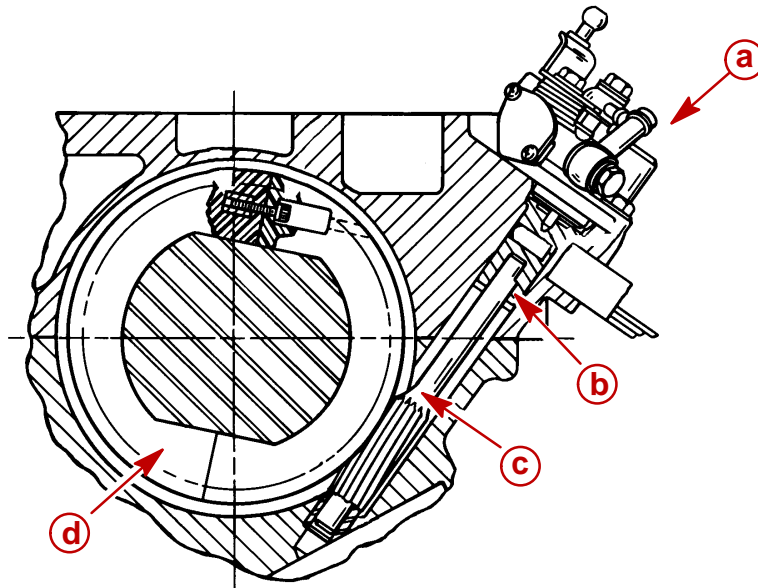
Mercury Marine will replace the coupler/bearing on affected Sport Jet 175 powerheads as listed above.

- a** - Oil Pump
- b** - Coupler/Bearing
- c** - Driven Gear
- d** - Oil Gear

Remove two screws securing the oil injection pump to the powerhead. Pull pump away from the powerhead exposing the coupler/bearing. Pull coupler out of bore. Install new coupler/bearing in the bore and connect to the driven gear. Apply Loctite 271 to threads of attaching screws and secure oil pump to powerhead. Torque screws to 25 lb. in. (2.8 N•m). Refer to the service manual (90-852396R1) for more detailed procedures.

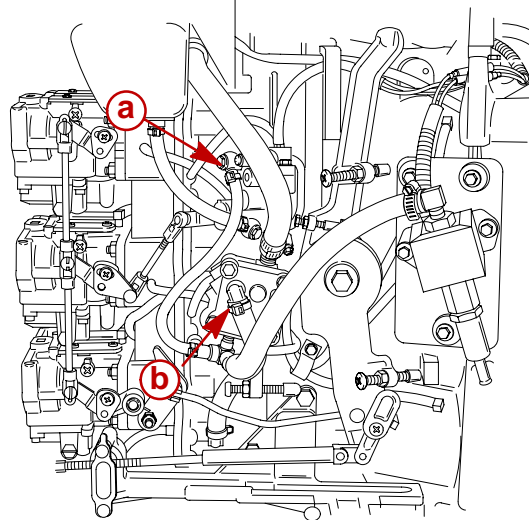
55087

- a - Pump
- b - Fuel Pump
