ADVISORY
 BULLETIN

No. 2001-06

Official Notification Federal Boat Safety Act Flywheel Nut Retorque - 115 EFI Four Stroke

2001 115 EFI Four Stroke

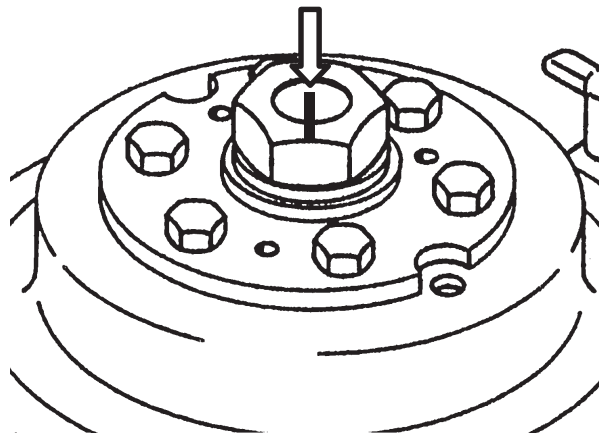
Outboards produced previous to serial number 0T388253 should be inspected for the yellow mark on the end of the crankshaft and flywheel nut or the yellow mark on the starter housing. There are additional color (white and red) marks on the end of the crankshaft and flywheel nut that are applied for other manufacturing aids.

Outboards with yellow marks have been reworked at Mercury Marine and do not require the retorque.

Factory Crankshaft and Nut Yellow Mark.

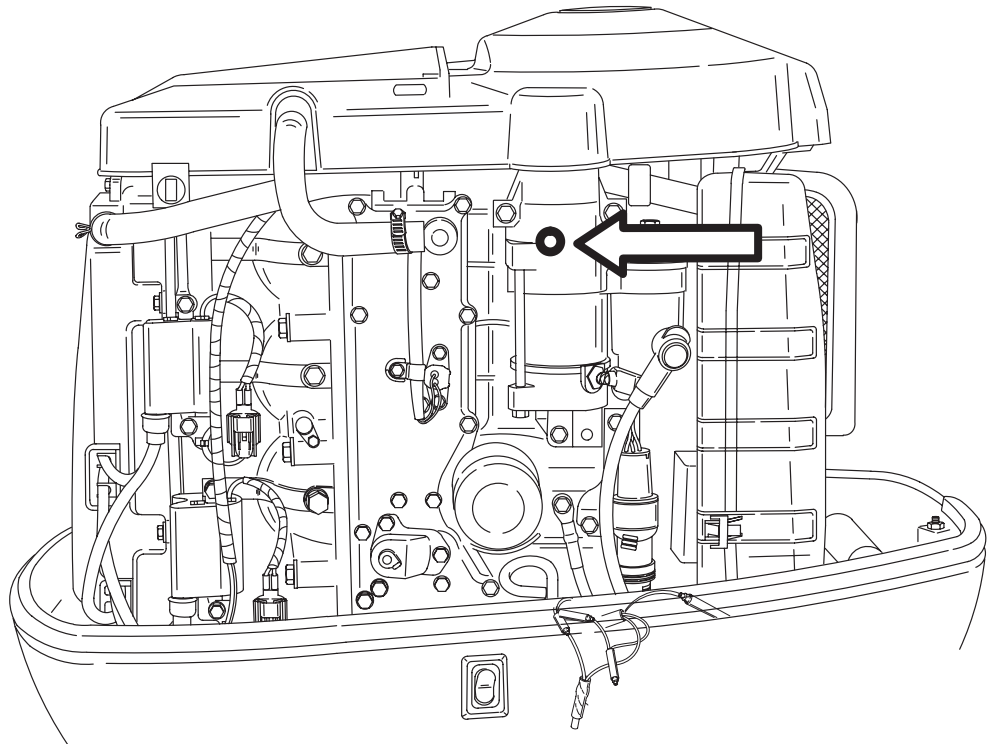
58655

Starter Motor Dot.**Correction**

Outboards without the yellow marks within the serial number range of OT332305 through OT388252 require retorquing of the flywheel nut.

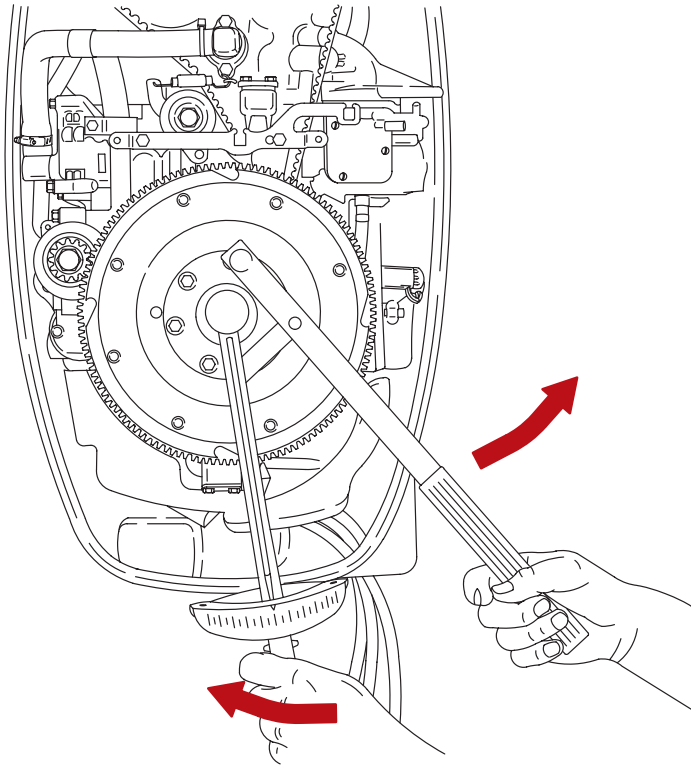
Torque Flywheel Nut to 140 lb-ft (189.8 N m)

2. Retorque the flywheel nut to 140 lb-ft. (189.8 N·m) with a torque wrench.
