service bulletin

Bulletin No. 2002-17
Jet Drive No. 2002-09

Key Switch Harness (859722A16) - Sea Doo Boats

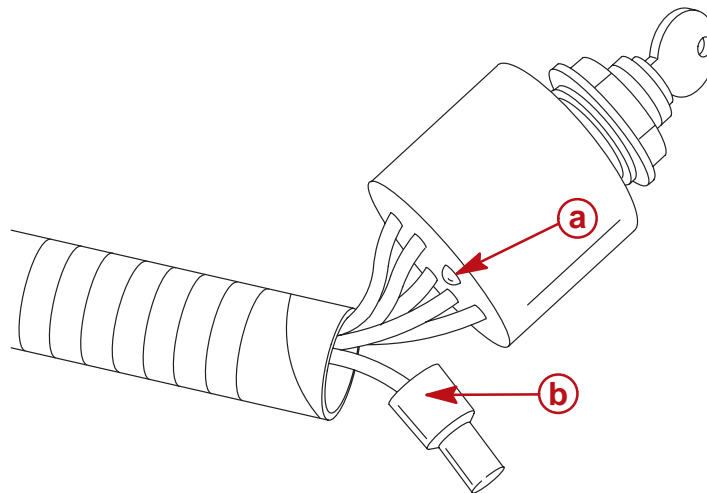
00162

There is a very remote possibility for damage to the powerhead PCM and the steering helm low speed control sensor using the key switch harness in the boats listed above.

- a** - Cut end of wire on switch
- b** - Wire nut

After gaining access to the back of the ignition switch, please observe that there are two similar wires coming out of the switch. One wire is a black wire with a yellow tracer and the other is a **yellow wire with a black tracer**. The correction is cutting the **yellow wire with a black tracer** as close to the ignition key switch as possible.

Apply RTV sealant (Loctite 5145 or equivalent) over the exposed end of the wire on the switch. Fill a wire nut with RTV sealant and install on the other end of the cut wire.

NOTE: Do not use an architectural grade or household window/door silicone sealant. These sealants contain acetic acid which is corrosive to electrical components.
