service bulletin

Bulletin No. 2002-14
OEM No. 2002-04

Uneven or Increased Handle Effort After Control Installation – Commander 3000 Classic Panel Mount Remote Control

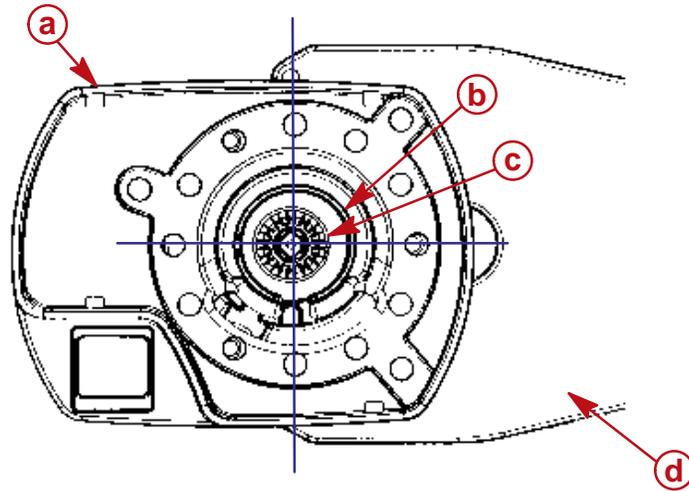
Misaligned Condition

If the amount of effort required to shift the control handle of an affected Commander 3000 panel mount control seems high or feels uneven (easier to shift from neutral to forward or from neutral to reverse and then harder in the opposite direction), the control's bezel may have been misaligned during installation. This condition may be caused by tightening the remote control module to the bezel plate with the remote control handle shaft not properly centered in the bezel plate hub opening. This may occur if the handle is placed into the bushing and bezel opening with the brass handle retaining nut tightened to 17 Nm (150 lb-in.). The handle hub may then rotate in a slightly non-concentric manner, causing the handle to drag or bind in one direction but not the other. If this misalignment condition is extreme, the handle may feel tight in both directions.
