## Electric Fuel Pump Harness Connection

### Models Affected

Mercury/Mariner Models	Serial Number or Year
135/150/175 HP OptiMax	S/N 0T776014 thru 0T790902 Model Year 2003

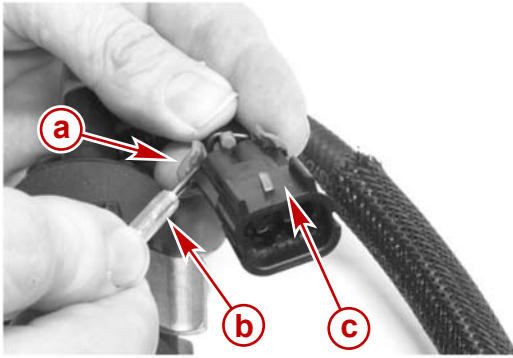
28019

- a** - Terminal retainer
- b** - Small screw driver
- c** - Connector housing

- Using a small flat bladed screw driver, pry off and remove the BLUE terminal retainer at the rear of the electrical connector.

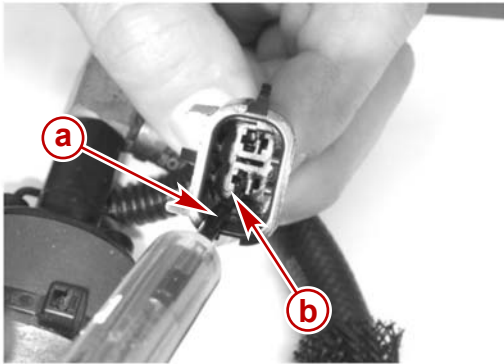
28020

- a** - Terminal removal tool
- b** - Insert removal tool in opening just above terminal to depress locking tab

- Using terminal removal tool, depress the locking tab on the wire terminal while applying light pressure on the terminal to push it out of the electrical connector housing or lightly pull on the wire while depressing the locking tab to remove from the connector housing.

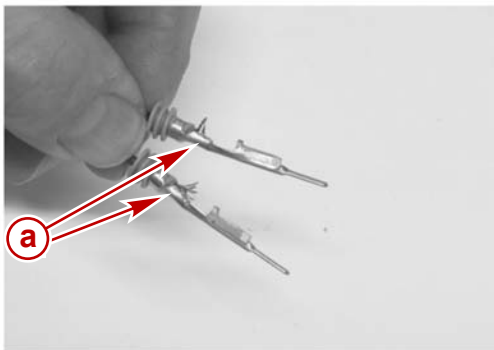
28012

Some low pressure electric fuel pumps may have incorrect crimping of the wire terminal connections. Some of the wire strands may not have been captured within the terminal crimp.

- a** - Incorrectly crimped terminal, wires outside crimp

If incorrect wire crimp is found on either wire terminal, replace the low pressure electric fuel pump following instructions in the 115 thru 175 HP OptiMax service manual 90-859494R1. If good terminal crimps are found on both terminals, reinstall the plastic connector housing using the following instruction.

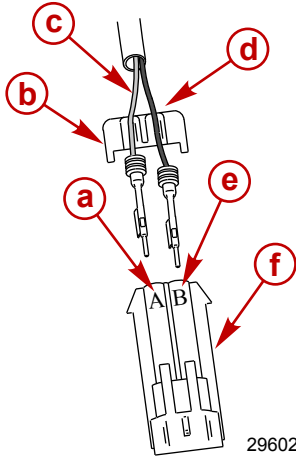
29602

- a** - (A) terminal receptacle
- b** - Terminal retainer
- c** - Red wire
- d** - Black wire
- e** - (B) terminal receptacle
- f** - Connector housing
