Service Bulletin

Bulletin No. 2008-03 OEM No. 2008-02

40/50/60 HP FourStroke Cowl Drain Valve Replacement and Top Cowl Latch Adjustment

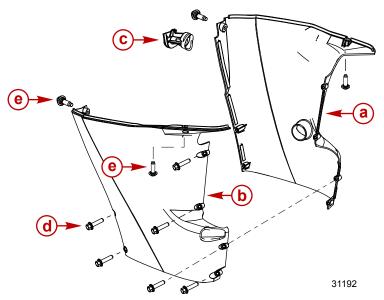
- a Port chap
- **b** Starboard chap
- c Idle relief port boot
- d Black flange bolt (M6 x 25) (6)
- e Black flange bolt (M6 special shoulder) (4)
- 1. Remove the cowl drains (there is one located on each aft rear corner of the engine).

NOTE: The installation of the replacement drains requires the removal of the top cowling and chaps. Please refer to the appropriate service manual for removal and installation instructions.
