Official Recall Notification U.S. Federal Boat Safety Act - Power Steering Tilt Helm

Mercury Marine has learned that there may be an issue with certain tilt steering mechanisms. The retaining pin for the steering knuckle may be loose which may result in a loss of steering. As a result, a Federal Boat Safety Act Recall of the at risk tilt steering mechanisms is being conducted. Because the recall is not focused on engines, there is no engine serial number range to exactly identify the product that requires the recall. As a result, at risk units must be identified by an inspection of the products that might contain the issue.

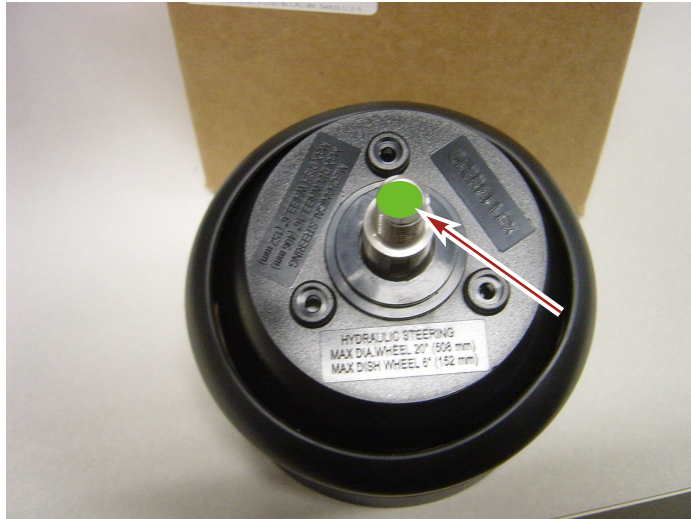
51110

Remove the steering wheel nut cover to expose the end of the steering shaft. Inspect for a green dot on the end of the steering shaft.

You may not have to remove the steering wheel to see the end of the shaft.

If a green dot is present, no further inspection is needed. The helm has already passed inspection at the factory. If no green dot is present, remove the steering wheel and the rubber seal.

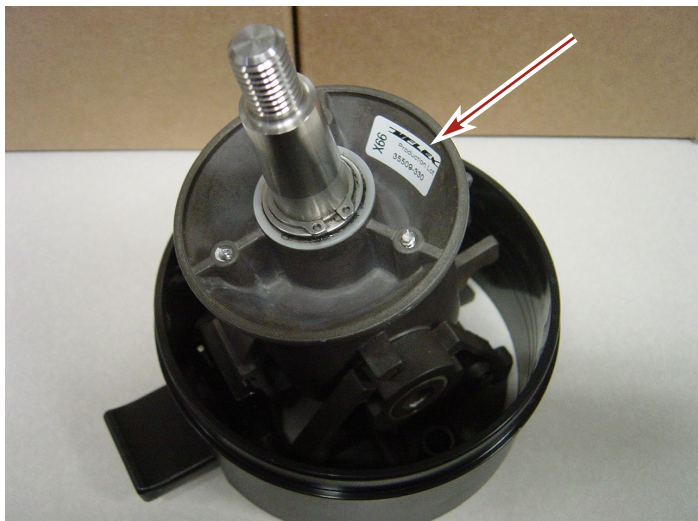
51114

Locate and inspect the date code on top of the tilt mechanism.

Date code

If the date code is not in the affected date range, place a green dot on the end of the steering shaft and reassemble.

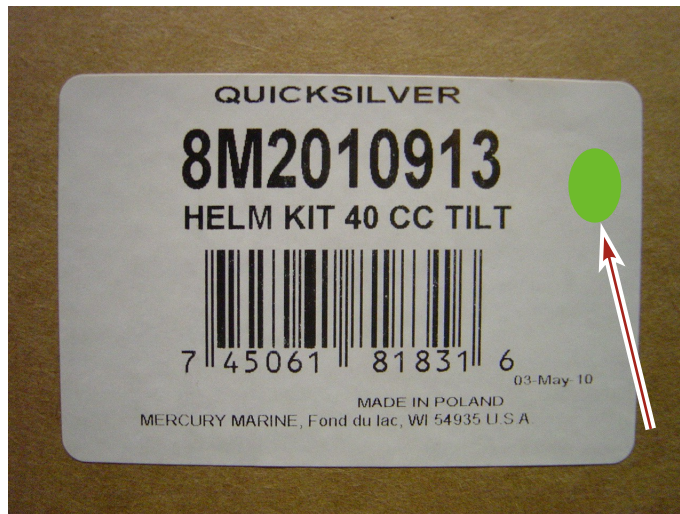
51117

A green dot will be on the kit label if the unit has been inspected.

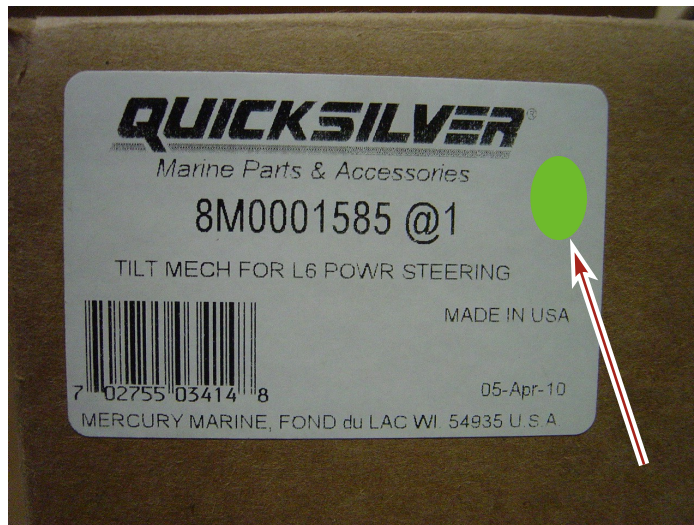
51118

A green dot will be on the tilt helm mechanism label if the unit has been inspected.

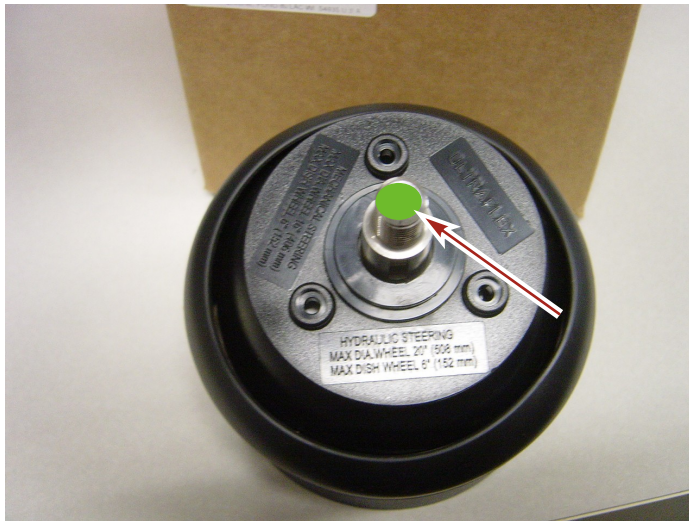
A green dot will be on the end of the tilt helm shaft if the unit has been inspected.

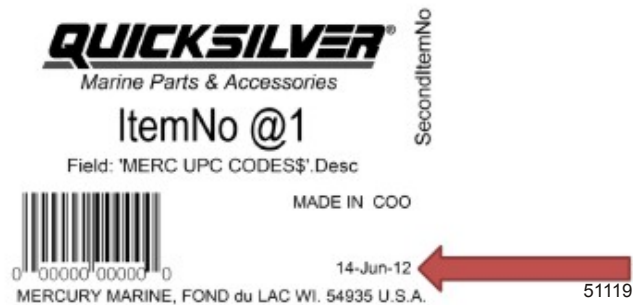
Date Code on Packaging

Mercury box dates after 14-June-12 do not need inspection.
