Service Bulletin

Bulletin No. 2013-13

Tilt Pin Spiral Retaining Ring Inspection – 200/225/250/300/350 SCi Verado L6

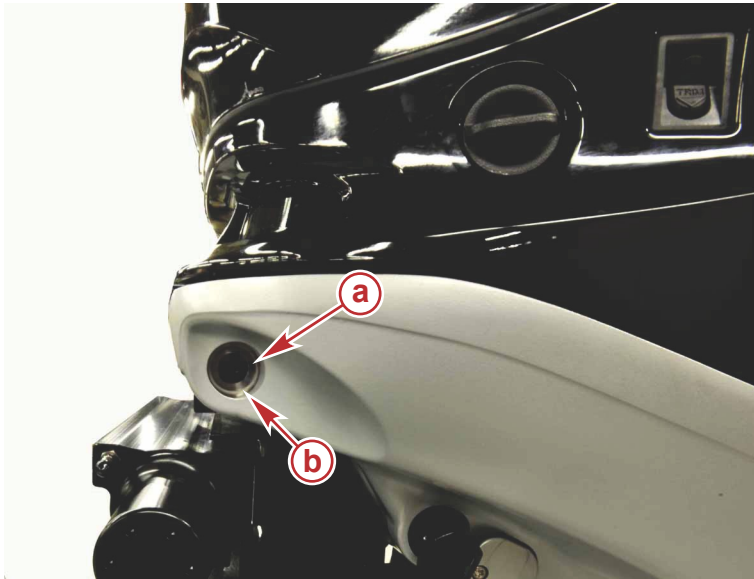
53971

- a** - Tilt tube (port side of mount cradle)
- b** - Tilt pin spiral retaining ring

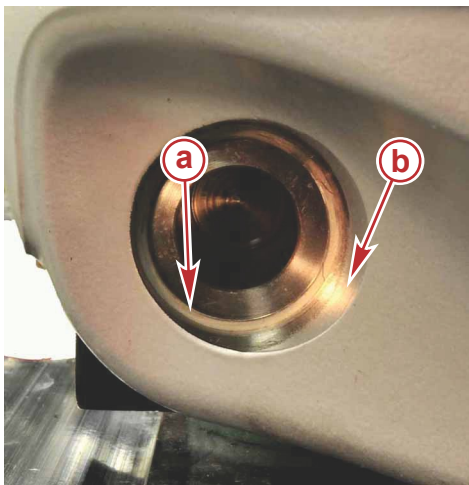
53972

- a** - Properly seated tilt pin spiral retaining ring
- b** - Tilt pin bore

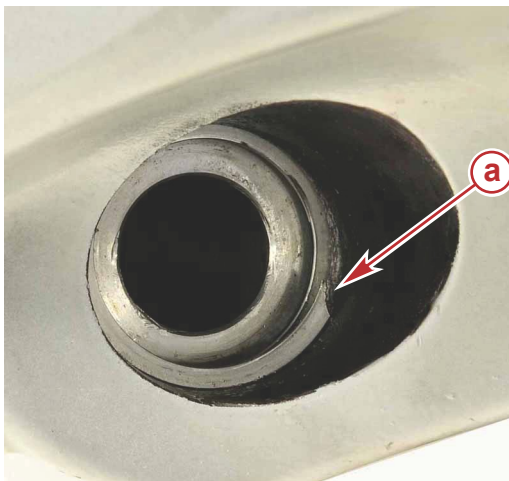
53973

- a** - Tilt pin spiral retaining ring not fully seated

Use a small screwdriver or punch to push any unseated portions of the tilt pin spiral retaining ring into the groove in the tilt pin bore.

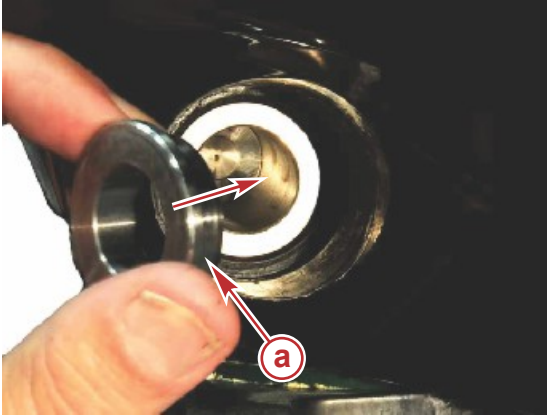
54029

a - Tilt pin spacer (350 SCi only)

1. If out of position, push the tilt tube into the tilt pin bore from the port side of the mount cradle to expose the groove in the tilt pin bore.
2. 350 SCi models: Verify that the tilt pin spacer is in position. Install a new spacer if it is missing.

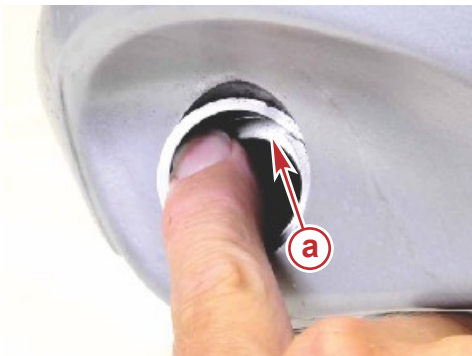
54031

a - Inner end of tilt pin spiral retaining ring

3. Install a new tilt pin spiral retaining ring into the groove in the tilt pin bore.
 - a. Separate the inner end of the tilt pin spiral retaining ring and start (push) it into the tilt pin bore in the mount cradle.
 - b. Continue to push the inner end of the tilt pin spiral retaining ring into the tilt tube bore so that it begins to wrap into the groove in the tilt tube.
