Service Bulletin

Bulletin No. 2017-06R1
Jet Drive No. 2017-01R1

2.5L 200 OptiMax SportJet Air Compressor Reed Failure

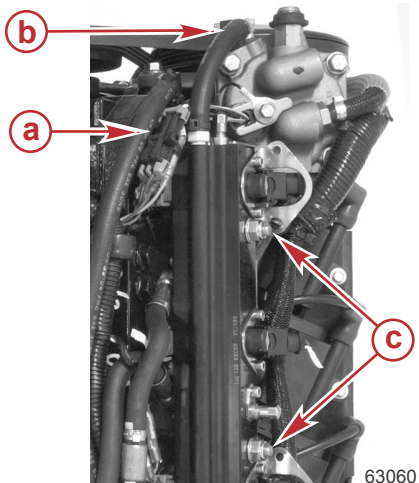
- a - Cylinder head temperature sensor harness connector
- b - Compressor water inlet hose
- c - Fuel rail mounting nuts (2)

3. Remove the two fuel rail mounting nuts.

4. Position the fuel rail out of the way, and complete the reed plate assembly replacement.

Before putting the engine back into service, be certain to reconnect all items and tighten the fuel rail mounting nuts to the specified torque.

Description	Nm	lb-in.	lb-ft
Fuel rail mounting nuts (2)	44.7	-	33

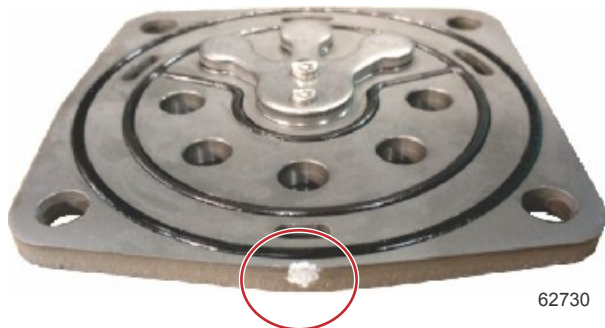
Reed plate assembly edge marked with a white dot

- To indicate that the rework procedure has been completed, mark the top edge of the replacement reed plate assembly with a white dot.
