Beaver Dam, Wis.
U.S.A.

MERCURISER SERVICE BULLETIN

Section: 11 (Installation)
Number: 363-06
Date: 4/29/63

- A. Transom Thickness Required for MerCruiser Installations
- B. Installation of Throttle, Shift & Ride-Guide Steering Cables
- C. Shift Cable Adjustments
- D. Competitive Remote Controls
- E. Engine-to-Drive Alignment
- F. "Hot Start" Problem & Remedy
- G. Automatic Choke Adjusting
- H. Engine Box Clearance & Vent

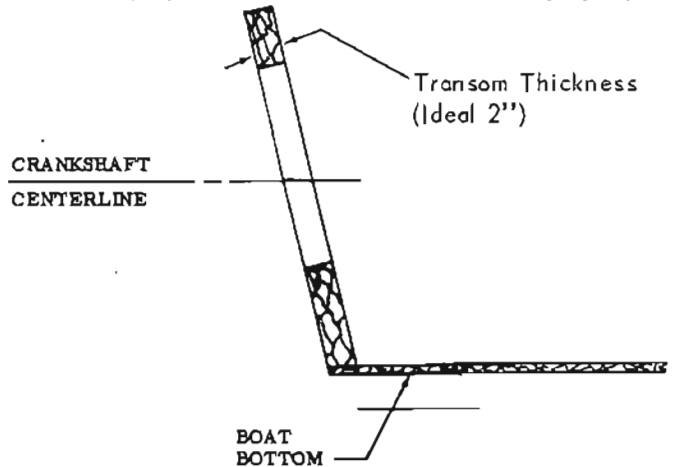
Figure 1. Ideal 2" Thickness

It has been brought to our attention that, in some instances, MerCruiser Stern Drive Units are being installed in transoms which are too thin to support drive unit properly or allow drive to function properly.

1. MerCruiser I Stern Drive Unit - 1-3/4" min. to 2-1/4" max.
2. MerCruiser II Stern Drive Unit - 1-7/8" min. to 2-1/8" max.

Ideal Thickness Is 2" (Figure 1)

If above transom thickness limits are not observed, the drive will not function properly. Transom must be of uniform thickness so that front and rear surfaces are parallel. Always check transom thickness before installing transom plates.

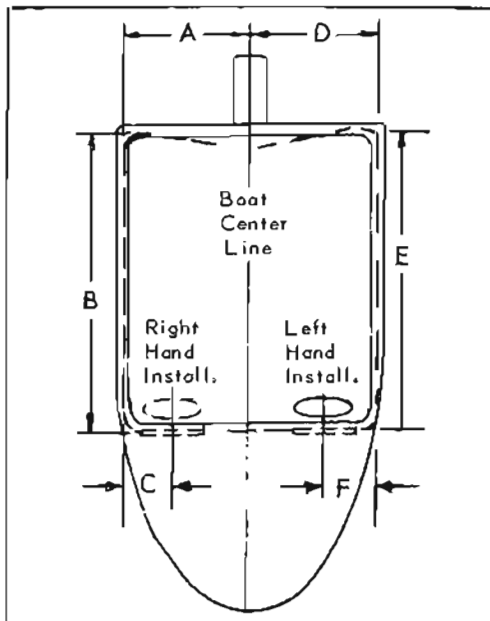
Figure 2. MerCruiser I Stern Drive Unit Ride-Guide Cable

Ride-Guide cable can be routed down right or left hand side of boat:

1. Add boat measurements A-B-C in inches for right hand installation.
2. Add boat measurements D-E-F in inches for left hand installation.
3. Subtract 30" (this allows for 12" radii at each cable bend).
4. Divide by 12".
5. This is cable length in feet.* (Order 34415A - cable only.)

NOTE: C & F dimensions must not be less than 18".

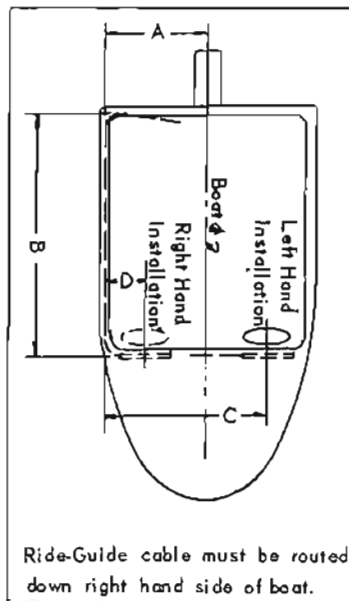
Figure 5.
MerCruiser II
Stern
Drive
Unit
Ride-Guide
Cable

1. Add boat measurements A-B-C in inches if steering wheel is located on left (port) side of boat
or
Add boat measurements A-B-D in inches if steering wheel is located on right (starboard) side of boat.
2. Subtract 38" (this allows for 12" radii at each cable bend).
3. Divide by 12".
4. This is cable length in feet for ordering.* (Order 34451A cable only.)

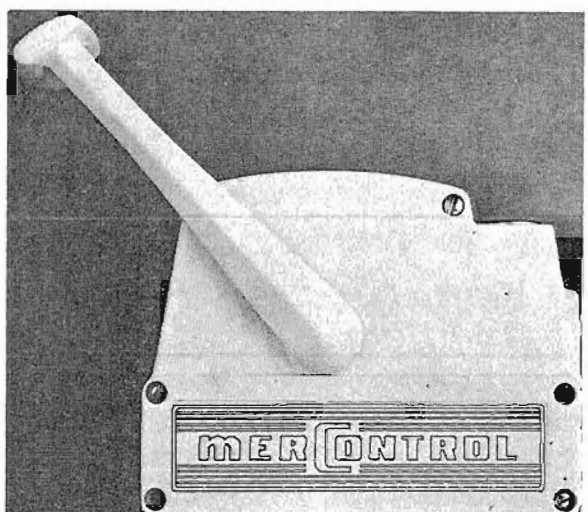
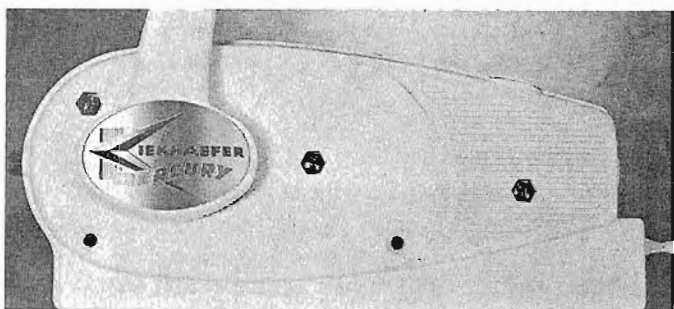
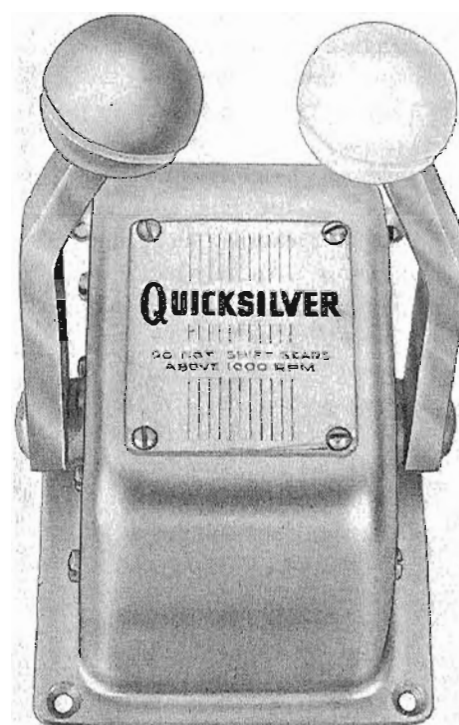
Figure 8. Quicksilver Remote Controls

The use of remote controls, other than those manufactured or recommended by the Kiekhaefer Corporation, has resulted in complaints of hard shifting on MerCruiser Stern Drive Units. These inferior controls have less mechanical advantage or leverage than do Kiekhaefer "Quicksilver" controls, thus, the operator must exert more force on the control handle to shift the unit. Some makes do not have sufficient cable travel to provide full forward and reverse gear engagement with subsequent damage to clutch.

We recommend Quicksilver Remote Controls for All Installations . . . Designed Exclusively for MerCruiser Stern Drive Units and MerCruiser Marine Engines. (Figure 8)

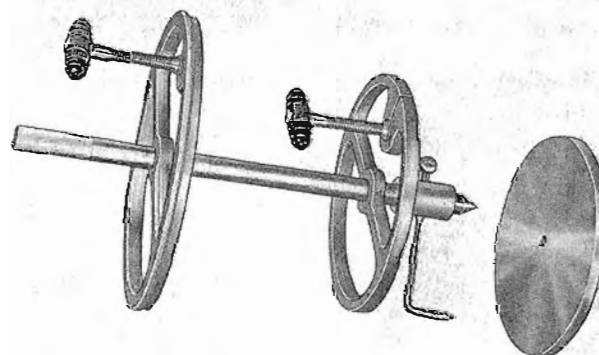
Figure 9. Engine Aligning Tool

Damage will occur to drive unit and engine coupling unless alignment instructions are followed.

It is necessary to use Alignment Tool 91-31620A1 when installing MerCruiser II Stern Drive Units. (Figure 9) This tool may be purchased direct from your parts distributor or the Kiekhaefer Corporation branch in your area.

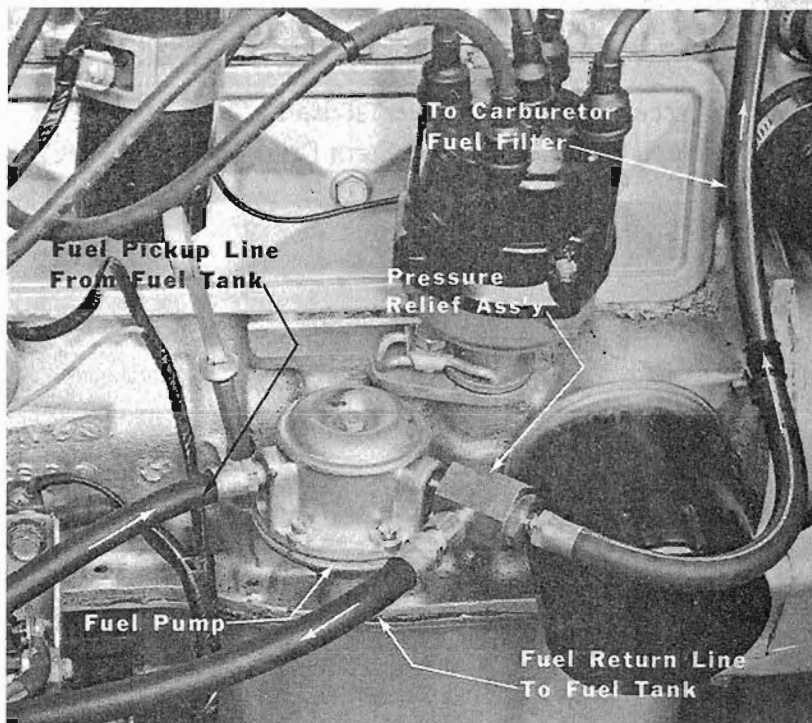
Figure 10. Fuel Return Line Assembly Installed
(MerCruiser "110" and "140" Shown)

In cases where engine boxes are tightly sealed or inadequately ventilated, temperature rises very high after use on a hot day. Consequently, the fuel in the fuel system, between the fuel pump inlet and carburetor, expands and forces its way into the carburetor where it overflows into the engine, flooding it and making starting difficult. To correct this condition . . .

1. Properly ventilate engine box. (Refer to Paragraph "H", following.)
2. If "hot start" condition persists, install bleed fitting and fuel line, as shown in Figure 10. Main fuel flow goes to carburetor in a straight path. A small amount of fuel passes thru the screen, then thru the small hole or restriction (which limits the flow) to a fuel line which returns to the top of the fuel tank. Do not return into fuel pickup or fuel pickup line. When the engine is stopped, and the temperature rises in the engine box, the fuel expands, with the excess volume merely passing back to the fuel tank via the restriction and line. This system is similar to that used in air-conditioned cars where temperature under the hood becomes excessive in hot weather. This return system is being installed as a standard part on current production.
