MERCUISER SERVICE BULLETIN

Number: 68-267-12

Date : 9/15/67

Reverse Lock Valve Readjustment - Power Trim

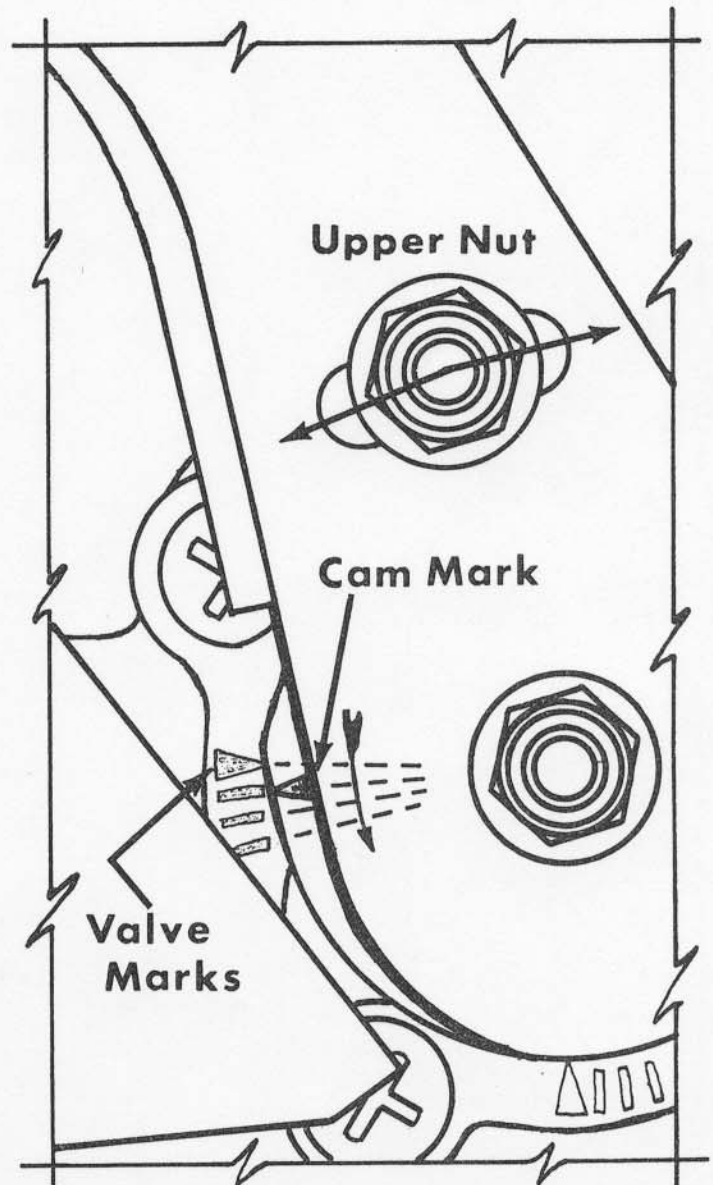
Shift Cable and Reverse
Lock Valve Adjustment

MerCruiser Stern Drives, which have improperly adjusted reverse lock valves, WILL NOT hold in reverse. If this situation exists, the shift cables and reverse lock valve require readjustment.

NOTE: If the unit will not hold in reverse, move cam one mark at a time and retest boat until unit holds in reverse. Refer to figure on right.

CAUTION: The unit may be locked in neutral if the reverse lock valve is over-adjusted.

When shift cables have been properly adjusted, and the drive unit will not hold in reverse, readjust the reverse lock cam as follows:

1. Loosen 2 nuts on shift lever.
2. Move upper nut in direction required to line up raised triangular mark on cam with raised triangular mark on reverse valve cover, then tighten 2 nuts on shift lever.
