MERCUISER SERVICE BULLETIN

Number: 68-14-09

Date : 5/16/68

D. MERCUISER II 1.33:1 DRIVE REVERSE HOOKS

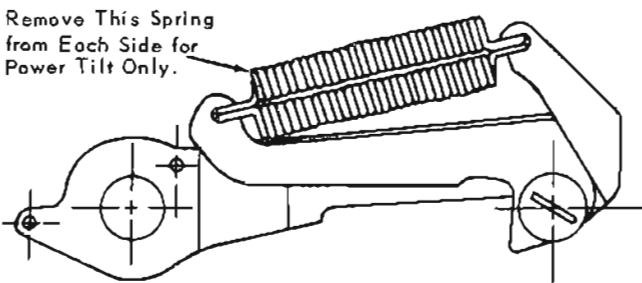
1. If a MerCruiser II drive (1.33:1) fails to hold when shifted into reverse it may be due to worn reverse hooks and worn or bent tilt pins which can cause malfunction of the reverse hook assembly. When replacing reverse hooks, check the following items which are also described on Pages 50 and 53 in Section IX of the MerCruiser Service Manual.

Figure 1. Reverse hook Assembly Spring

- a. Proper amount of springs on the reverse hook assembly. (Figure 1)
 - b. Reverse lock cam positioned properly for drive rotation. (Figures 2 and 3)
 - c. Reverse lock cam shimmed to correct clearance. (Figure 4)
 - d. Unit and control cables adjusted to specifications.
2. Reverse hook (B-38382) material has been improved to resist wear at the tilt pin area. The new hook is charcoal black with chrome plating at the hook end.

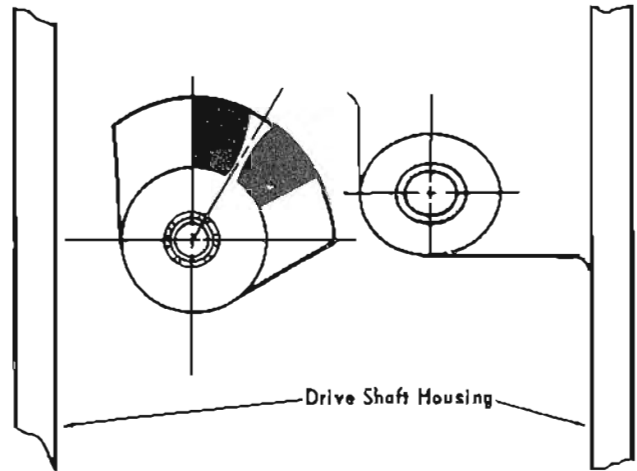
Figure 2. Cam Position - Forward Gear, Left Hand Rotation

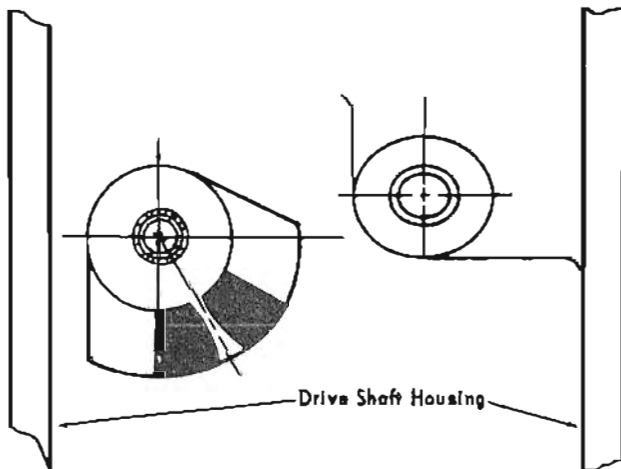
Figure 3. Cam Position - Forward Gear, Right Hand Rotation
