MERCRUISER SERVICE BULLETIN

Number: 68-16-11

Date : 6/28/68

READJUSTING CABLE END GUIDE TRAVEL - MerCruiser II

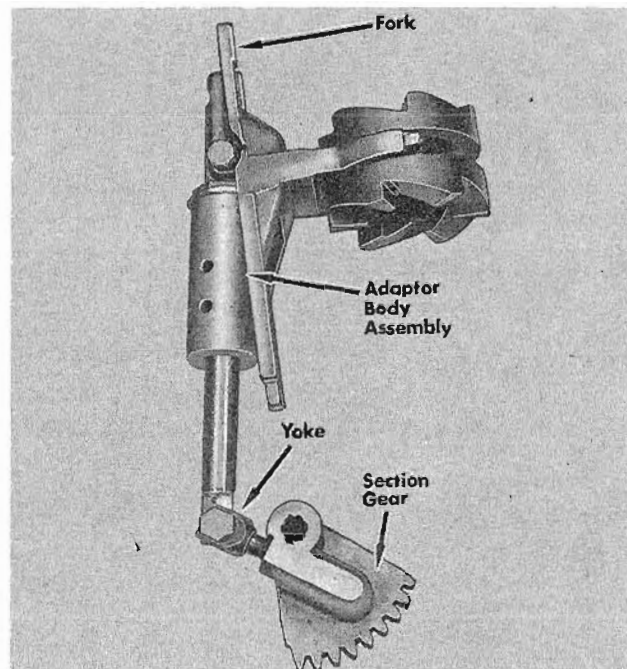
Figure 1. Yoke Attached to Cable and Sector Gear

A number of MerCruiser II Stem Drive Units (between Serial Nos. 2398798 and 2453673) were assembled with excessive inner shift cable travel ($2\frac{1}{4}$ " rather than the correct 2"). This possibly could permit the engine to throttle before it is fully shifted into forward or reverse.

1. Drain approximately one quart (.946 liter) of gear lubricant into a clean container for refilling drive.
2. Remove rear cover (6 screws) and remove shifter fork from clutch.
3. Turn yoke "out" to decrease cable travel. Adjust yoke one full turn at a time to prevent adaptor body from striking back of yoke. (Figure 1)
4. Reinstall screw thru shifter fork and adaptor body. Place rear cover on drive shaft housing and secure with 2 screws.
5. Check shift cable travel, preceding.
6. After adjustment has been completed, install new gasket on rear cover and fasten cover to drive shaft housing with 6 screws, then refill drive with quart of gear lubricant removed previously.
