MERCUISER SERVICE BULLETIN

Number : 71-9-06

Date : 6/24/71

MerCruiser "888" Power Trim Pump Wiring (New Model)

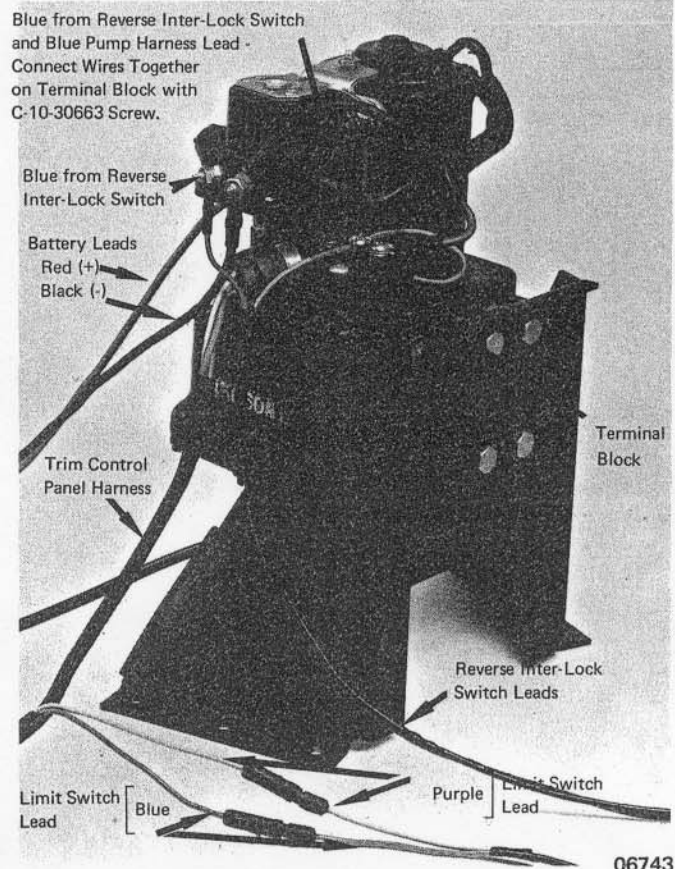
Figure 1. MerCruiser "888" Power Trim Pump Wiring

The Power Trim pumps, shipped with MerCruiser "888" Power Packages from our Fond du Lac warehouse before April 26, 1971, are wired incorrectly. The blue pump harness lead on these pumps is connected to, and must be removed from, the pump solenoid.

WARNING: Operation of an incorrectly wired pump may result in damage to pump, reverse lock valve, trim cylinders, wiring and/or trim system connecting hoses and lines.

Inspect all MerCruiser "888" Power Trim pumps, installed in boats that you have in stock and have sold, to be sure they are wired correctly, as follows: (Refer to Figure 1 on right.)

The blue pump harness lead and one of the blue reverse interlock switch leads must be connected to the terminal block as shown in the illustration (right).

Screw C-10-30663 is required for making this connection. Order a quantity of screws to cover your units.

IMPORTANT: Correct length screw must be used to make this connection. If screw is too long and protrudes thru terminal block, wires will be shorted to ground.
