MERCUISER SERVICE BULLETIN

Number: 71-11-08

Date : 7/22/71

- A. Location of MerCruiser V-8 Stern Drive and Inboard Engine Exhaust Elbows in Relation to Boat Waterline
- B. Exhaust Outlet Location and Installation
- C. Exhaust System Installation
- D. Warranty

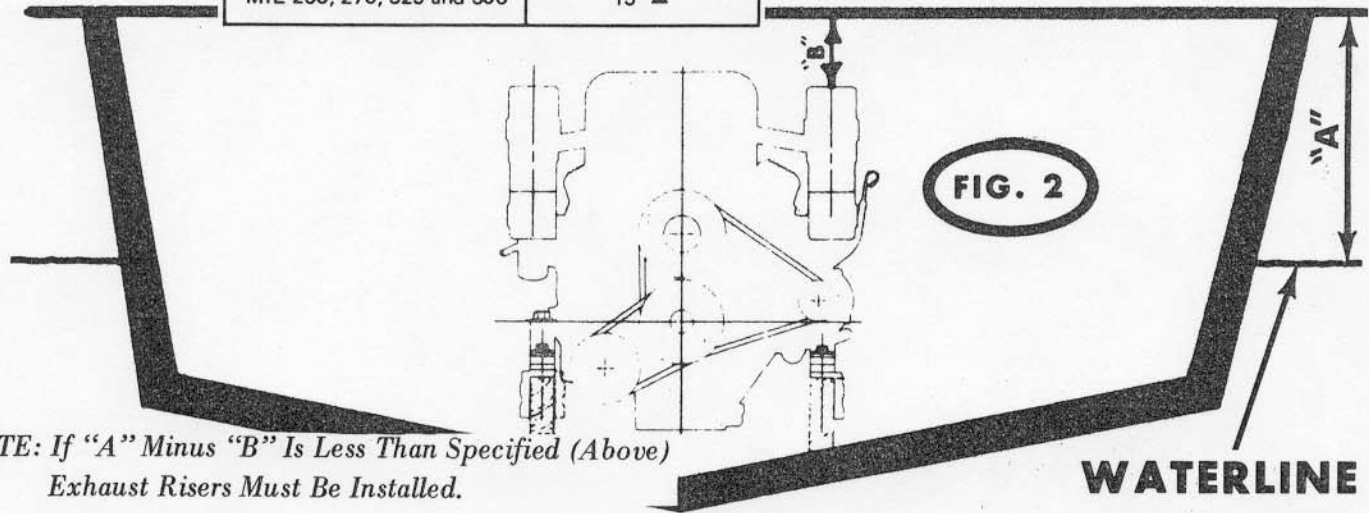
FIG. 2

We have received reports of water entering the exhaust manifolds and combustion chambers of MerCruiser V-8 Stern Drive and Inboard Engines. The problem is caused by exhaust elbows which are not located a sufficient distance above the boat's highest waterline when boat is at rest in the water. It is the obligation of the boat manufacturer or installing dealer to correctly locate the engine for installation. Therefore, if water is present in the exhaust manifolds or combustion chambers of the engine, the product has not caused the problem, unless there is a defective part.

MINIMUM distances and method of measuring a completed installation are shown in the chart (Figure 1) and drawing (Figure 2), over. If distance is less than minimum specified, exhaust elbow risers must be installed as listed in chart (Figure 3).

NOTE: Take Measurement "B" at Highest Point in Exhaust Elbow.

NOTE: If "A" Minus "B" Is Less Than Specified (Above) Exhaust Risers Must Be Installed.

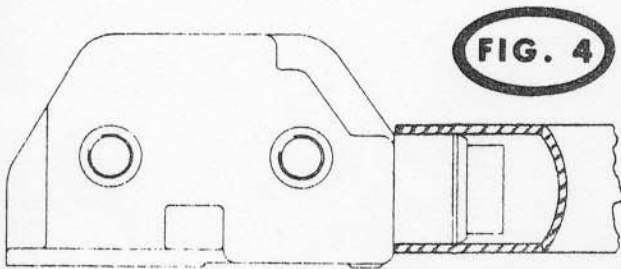
CORRECT

The exhaust hose, which connects to the exhaust manifold elbows on MerCruiser 200, 215, 225, 250, 270, and 325 Stern Drive Engines and on MerCruiser 215, 250, 270, 325 and 390 Inboard Engines, should be connected so that it does not restrict the flow of discharge water from the elbow.

Hoses must be connected as shown in Figure 4. It is recommended that these hoses be checked when servicing the model engines listed in the preceding paragraph.

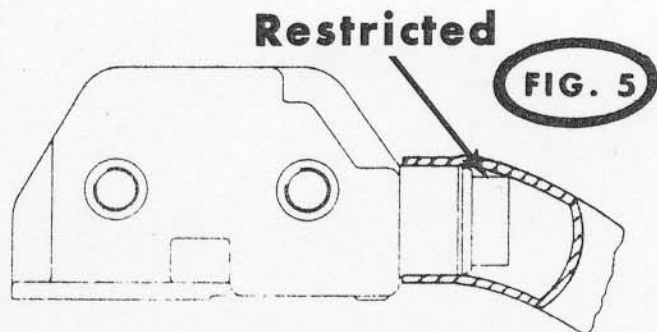
INCORRECT

Hoses, which are connected as shown in Figure 5, will prevent discharge water from flowing around the entire inside diameter of the hose and will cause a hot spot that may burn thru.
