- A. Ride-Guide Steering Cable Assembly Parts Change
- B. MerCathode Electrode and Anode Installations
- C. Linear and Rotary Electric Trim Indicator Sender - Check Procedure
- D. Trim Indicator System Check
- E. Vented Top Cover Seal - MerCruiser 120-140-160 Models

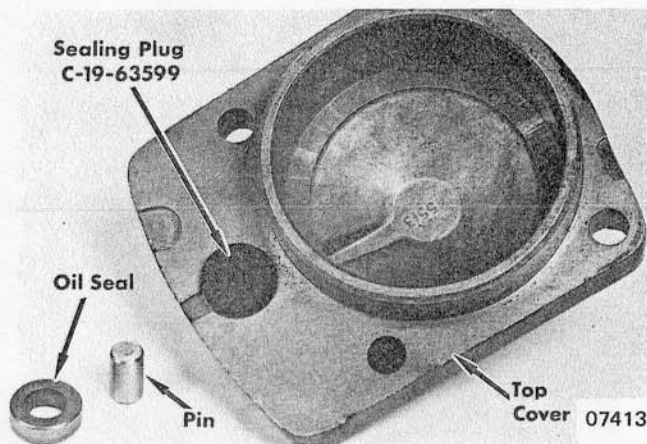
Figure 1. Sealing Plug Installed

MerCruiser 120 and 140 Stern Drives (Serial No. 2062141 thru 2266775) and 160 Stern Drives (Serial No. 2065190 thru 2269838) were built with vented top cover assemblies.

Service replacement top cover assemblies will not be vented.

Whenever these drives are serviced, we recommend removing the oil seal and pin from the cover and installing new sealing plug C-19-63599. (Figure 1)
