- A. MCM 120-thru-888 Shift Cutout Switch Adjustment
- B. MCM 120-thru-888 Shift Improvement Kit (B-65037A1)
- C. MCM 120-140-165 Shift Cable Damage Prevention
- D. MCM 215E and 215H Bell Housing Gasket Installation
- E. MCM 215E Shift Actuator Assembly (B-54240A5) Exchange - Reprint

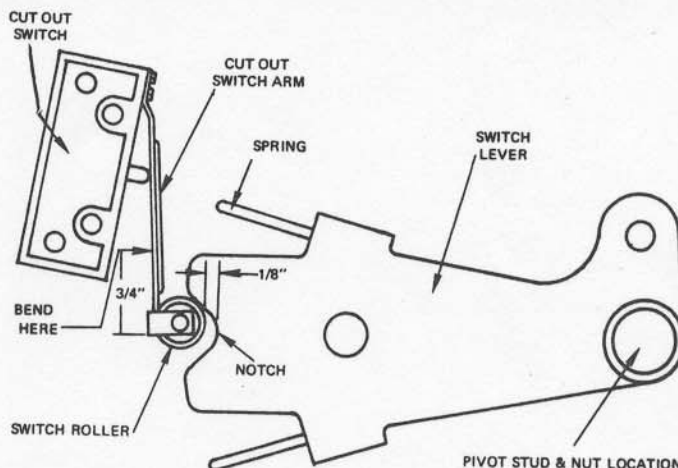
**Figure 1. Cutout Switch Adjustment**

The shift cutout switch MUST BE operating and adjusted to cut out the ignition momentarily during stern drive unit shifting. This relieves the torque load on the sliding clutch in the gear housing. The lever that actuates the switch senses the control shift cable movement to accomplish this action. If a shifting problem exists after the shift cable installation and adjustment procedures (outlined in the MerCruiser Service Manual) had been properly accomplished, adjust cutout switch as follows:

1. Clean and lubricate the cutout switch assembly.
2. Loosen pivot nut (if tight) and lubricate shift lever pilot stud with Multi-purpose Lubricant (C-92-49588) to ensure that the switch arm roller returns freely to center of notch.
3. Connect switch leads to continuity meter.
4. Move switch lever slowly by hand and note roller position in lever notch when circuit is closed. (Figure 1) Switch roller should not be more than

1/8" (3.2mm) from bottom of notch. If more than 1/8", bend switch arm at a point approximately 3/4" (19mm) from end toward the bottom of the notch to obtain a closed circuit within 1/8" from bottom of notch.

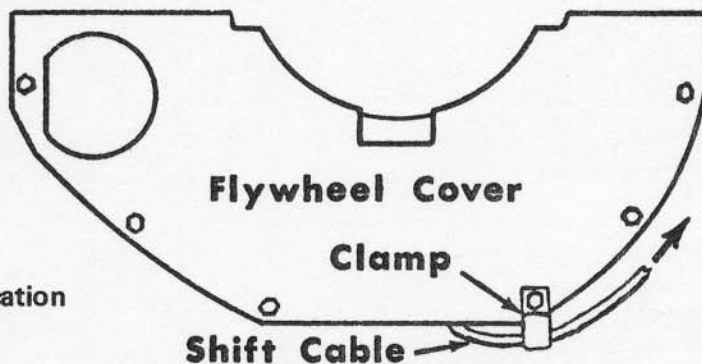
Figure 2. Flywheel Clamp Location

Under certain conditions during severe boat operation, the MCM 120-140-165 stern drive shift cable could become damaged between the gimbal housing exhaust elbow and the engine flywheel housing, making it inoperative. As a precaution, keep the shift cable away from this area. Install clamp (C-54-52923) on the engine flywheel housing cover and route the shift cable through the clamp. (Figure 2) Remove screw from the bottom left side of the flywheel cover and replace it with screw C-10-26065, fastening the clamp (C-54-52923) in a vertical position. The stern drive unit shift cable **MUST BE** routed through the clamp horizontally.
