## PROPELLER INTERFERENCE WITH TRIM TAB ON MERCUISER I STERN DRIVES

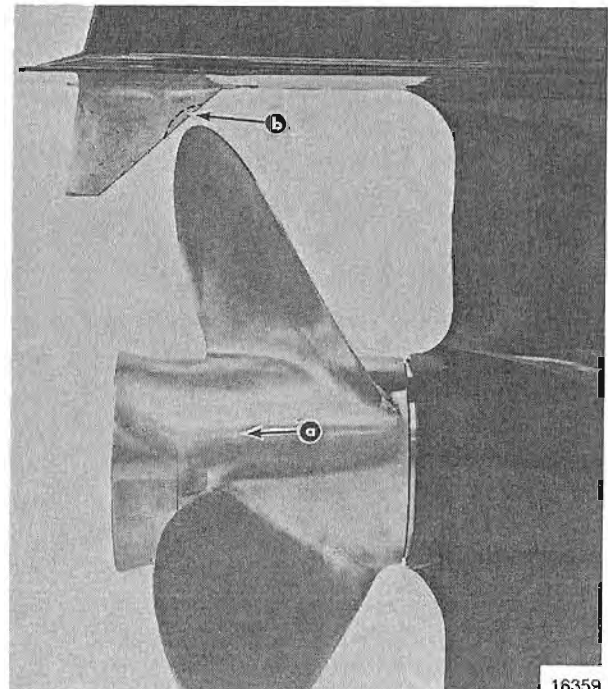
**Figure 1. Checking Propeller to Trim Tab  
Clearance**

To check for adequate clearance, pull propeller rearward while checking clearance between trim tab and each propeller blade. (Figure 1) A minimum of .100" (3/32" or 2.54mm) clearance should exist. If clearance is insufficient, check for the following:

- That short trim tab (31640A1) is being used. Use of long trim tab (34127A1) will cause interference.
- That forward thrust hub (77987) is being used. Use of forward thrust hub (56292A1 or A2) will cause propeller interference.
- That spline washer is engaged with splines on propeller shaft. Failure to mate splines will prevent propeller nut from drawing propeller into proper position on shaft.
- That propeller nut is torqued to 55 lbs. ft. (74.6 N.m) minimum.

If none of the preceding are the cause for interference, the trim tab **MUST BE** modified to provide sufficient clearance. Remove stock from trim tab with a file or a grinder, at location shown in Figure 1. Do not remove any more stock than absolutely necessary.

- a - Pull Propeller Rearward
- b - Remove Material from This Area Of Trim Tab  
If Clearance Is Less Than .100" (3/32" or 2.54mm)
