NUMBER: 84-20

- A. MerCruiser I and TR Models Making a Whining Noise
- B. New Transmission Shift Lever on MerCruiser 370TRS/400TRS

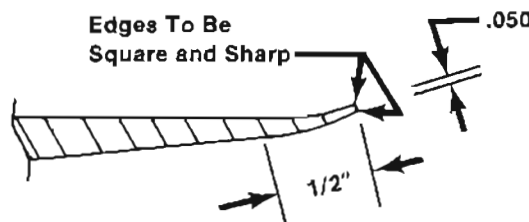
Figure 1. Propeller Modification

If you encounter a MerCruiser I or TR model that makes a whining (singing) noise between 800 and 1200 RPM in forward gear, problem may be caused by the propeller blades having too thick of a trailing edge. To the best of our knowledge, only Black Max and TR propellers are subject to this problem. In most cases, the whining condition can be eliminated by performing the modification outlined following.

1. Thin trailing edge of blades to 0.050" (1.3mm), by removing material from side opposite the cup (low pressure side). Blend into original thickness approximately 1/2" (13mm) forward of trailing edge. Thin each blade from root to center of tip.
2. Remove any roughness on cup side of blades.
3. After thinning blades, file trailing edges so that edges are square and sharp.

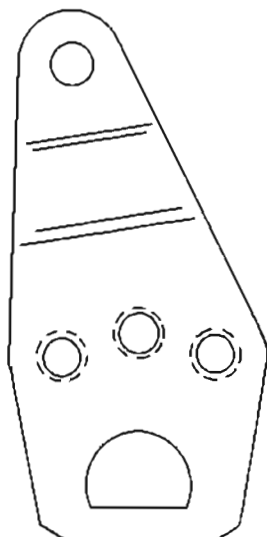
New Lever

A new transmission shift lever 12128 is now being used on 370TRS and 400TRS models. (Figure 2) Starting serial numbers for engines with the new lever are shown following:

The new shift lever enables any of the Quicksilver Remote Controls to be used with these engines. With the old lever, only the Quicksilver Two-Lever Remote Control could be used. Remote control binding would occur if a single-lever control was used.
