NUMBER: 85-6

- A. Power Trim Pump 20 Amp Fuse Blowing on MerCruiser 120-thru-300 R & MR Models
- B. MC-I Gear Housing Shimming Tool, 91-56048
- C. MC-I Gear Housing Reverse Gear, 43-61026

A. POWER TRIM PUMP 20 AMP FUSE BLOWING ON MERCRUISER 120-THRU-300 R & MR MODELS

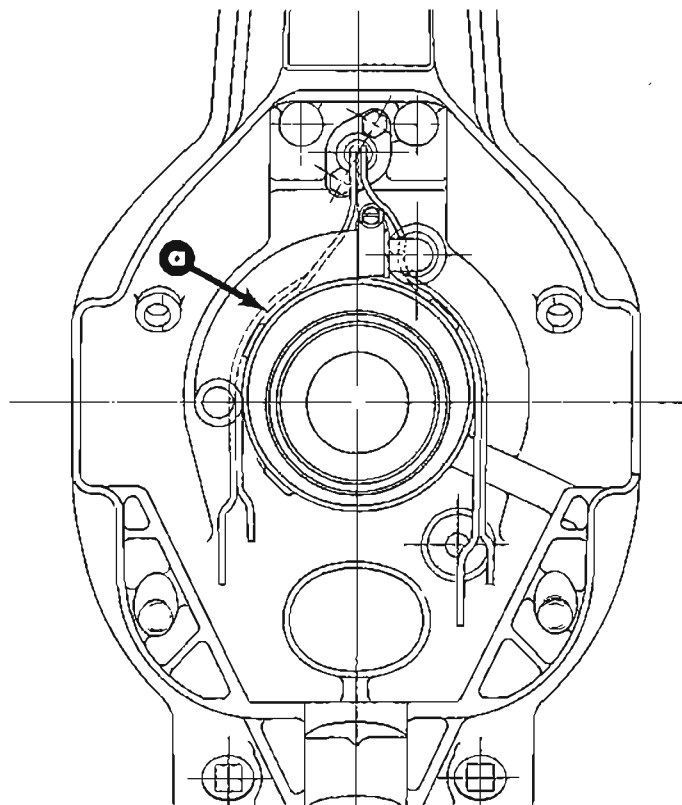
Figure 1. Trim Limit Switch Leads Shorting Out

If you encounter a MerCruiser 120-thru-300 R & MR model that blows the 20 amp fuse on the Power Trim pump when trimming "Out/Up", problem may be due to the trim limit switch leads shorting out. We have received reports where the insulation on the leads has chafed thru and allowed the conductor to come in contact with the gimbal housing, causing the shorting condition. (Figure 1)

a - Leads Chafe Thru and Short Out In This Area

To correct this condition, install new trim limit switch and lead assembly 99122A2 and route leads as shown in Figure 2.

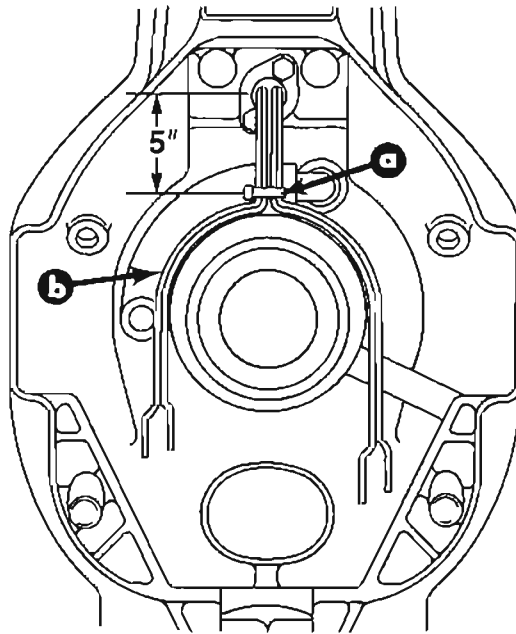
Figure 2. Trim Limit Switch Lead Routing

- a - Sta-Strap 61990
- b - Route Leads on Front Side of Hose (As Viewed From Rear)

MerCruiser 120MR-thru-300MR models with transom assembly serial number 0A354131 and above will have the trim limit switch leads re-routed from the factory.

New routing method should be used whenever servicing any MerCruiser I model with trim limit switch on side of gimbal ring.

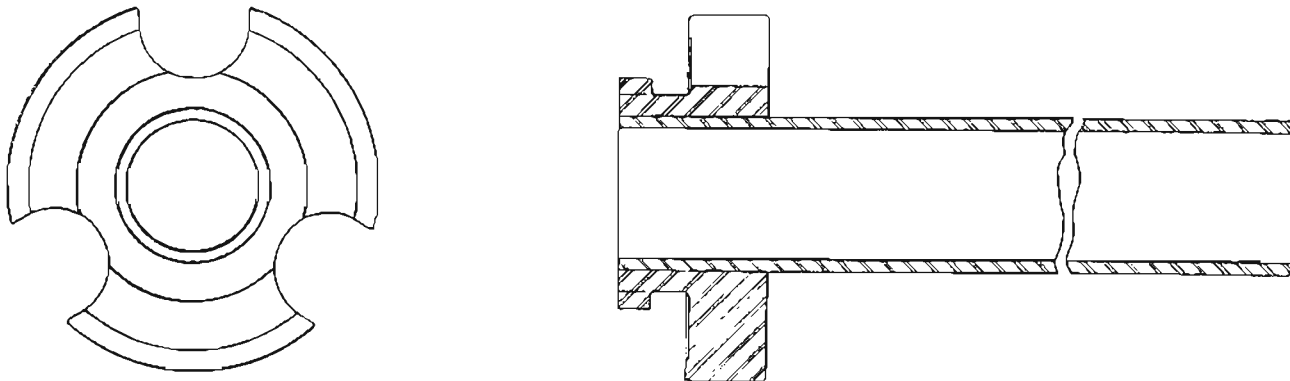
Figure 3. Shimming Tool, 91-56048

Shimming Tool, 91-56048 has been changed to incorporate 3 shimming locations. (Figure 3) The 3 locations are identical and any one of the three may be used. Change was made to extend tool life. Part number will not be changed.
