service bulletin

Piston Knock in MCM 224 CID (3.7 Litre) Engines with Aluminum Exhaust Manifolds

No. 88-2

Borg Warner V-Drive Oil Capacity Increase

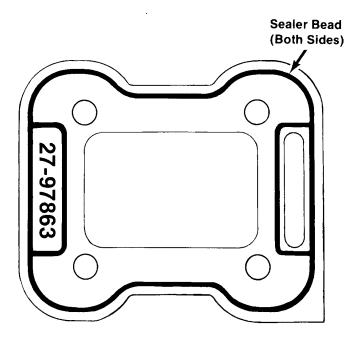
Figure 1.

There has been a few reports on the MerCruiser 224 CID 3.7 litre engines with aluminum exhaust manifolds having a piston knock caused by a tight piston pin. The starting serial numbers of engines with aluminum exhaust manifolds are 165/170 3.7L A528109 and up, 180/190 3.7 L/LX A528516 and up. The tight pin may be caused by engine coolant entering the cylinders because of a leaking exhaust elbow/reservoir to exhaust manifold gasket part number 27-97863. The early style 27-97863 gasket had a silicon seal on both sides. The later style 27-97863 gasket was changed to a graphite type (Figure 1). 27-97863 is now superseded to 27-18272 which is a graphoil/tin composite (Figure 1). Starting serial numbers of production engines, with the 27-18272 gaskets are 165 3.7L B742442 and up 180 3.7L/LX B743204 and up. Gasket part number 27-18272 is also in Quicksilver parts stock.

27-97863 27-18272

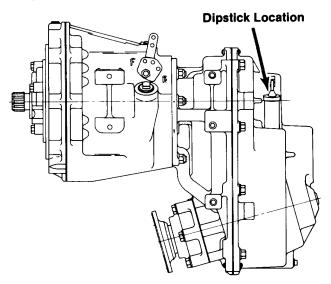
Figure 2.

Borg Warner V-Drive transmissions with dipstick located in V-Drive case (Figure 2) that have had intermediate shaft rear bearing failure should have oil capacity increased.

Dipstick 10-05-559-001 (Figure 3) is now available for use in Velvet Drive[®] V-Drive transmissions which have the dipstick in the V-Drive case. The new dipstick will provide for additional oil capacity. Order new dipstick from your closest velvet drive distributor as shown on map. The following illustration shows the dimensions of the new dipstick. It is recommended that the new dipstick be installed when servicing any V-Drive transmission which has the dipstick located in the V-Drive case.

Original dipsticks can be modified to current design by adding a mark 1" (2.5mm) above the original "full" mark. The original "full" mark then becomes the "low" or "add oil" mark.
