TO: SERVICE MANAGER  TECHNICIANS   
PARTS MANAGER

No. 89-22

## Alpha One Transom Assembly Bell Housing Shift Slide 33981T on 1989 Transom Assemblies Only

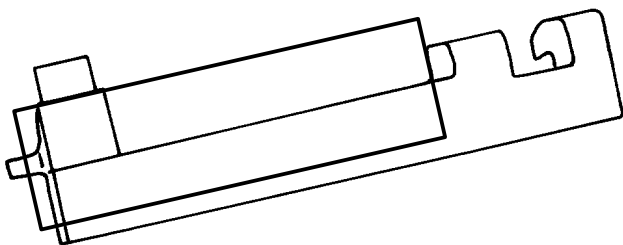
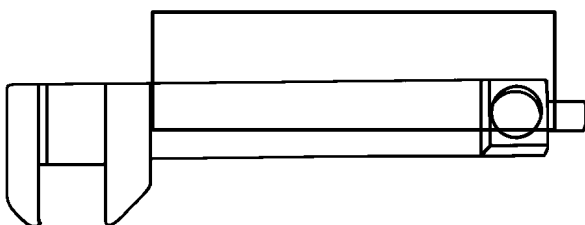
It has been brought to our attention that on some 1989 model Alpha One Transom Assemblies, the shift slide could possibly rub or bind in the drive shaft housing shift cavity when shifting into forward gear this will cause the shift cable to activate the shift interrupt switch and shut off the engine when shifted into forward gear. To correct the problem the following must be done.

1. Shift remote control into full forward (W.O.T.) position to extend the shift slide to its maximum travel position.
2. Remove drive unit.
3. In area shown in the following photos, remove the casting line slag with a file.

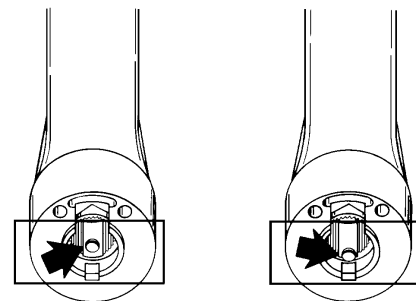
It has been brought to our attention that the set screw which secures the handle to the center shaft of the control is pushing the handle back away from the control bezel. This may allow the handle, after a period of time, to miss the lock slot in a neutral position at the cam on the control module. When the set screw hole is drilled at the wrong angle the screw will push the handle back away from the lock ring and the handle may not lock out in the neutral gear position. If so, replace handle with a new one.

GOOD

BAD
